- ✓ QUV chamber test up to 3000 hours
- ✓ Observation & record in every 500 hours

NEWTECHWOOD ULTRASHIELD® 500 HRS: DELTA E: 0.65 -1.25

Tested in a QUV chamber for 3000 hours, experts say no visible colour change can be observed at a Delta E < 5.0

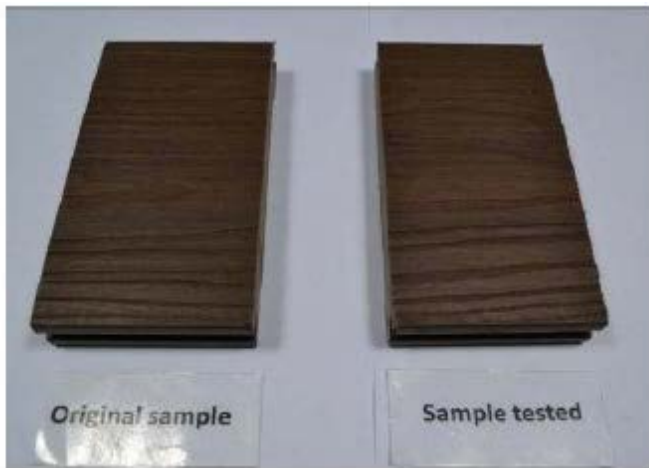
Model: US01.
After 500 h test, Gray Scale=4-5, $\Delta E^*=0.65$

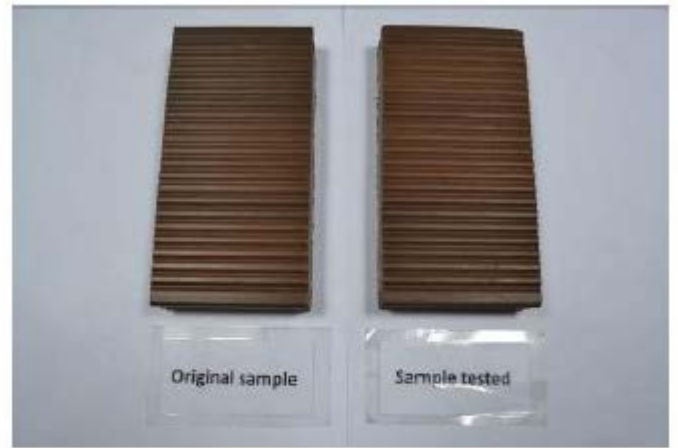
Model: US02.
After 1000 h test, Gray Scale=4-5, $\Delta E^*=1.33$.

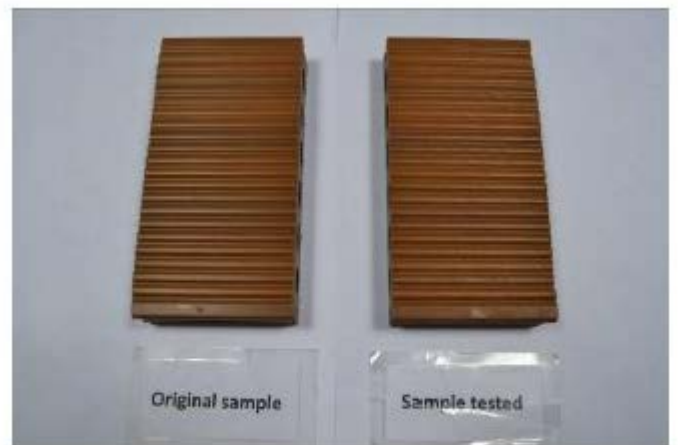
Model: UH07.
After 1000 h test, Gray Scale=4-5, $\Delta E^*=1.41$.

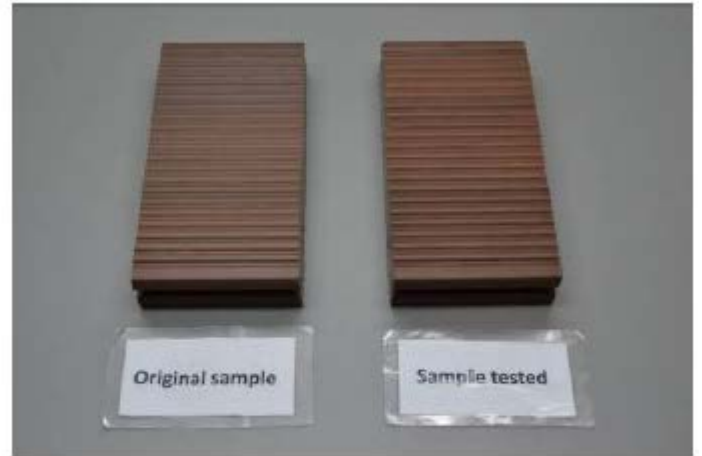
Model: US02.
After 1500 h test, Gray Scale=4, $\Delta E^*=1.60$

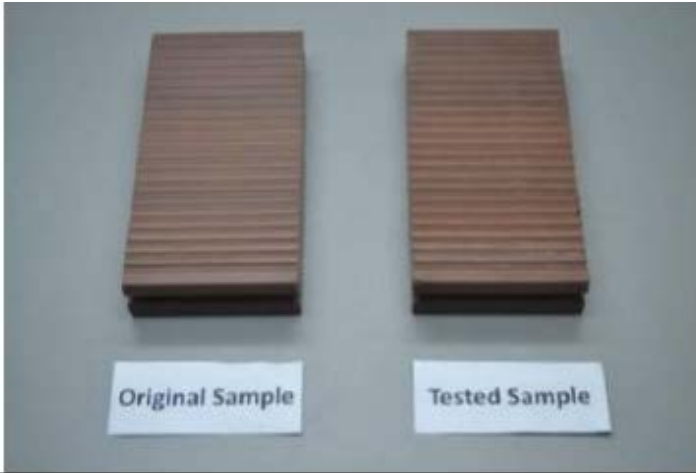
Model: US02, Part showed some color change. There was no other visible surface damage. After 3000 hours test, $\Delta E^*=3.75$ Gray Scale 3.

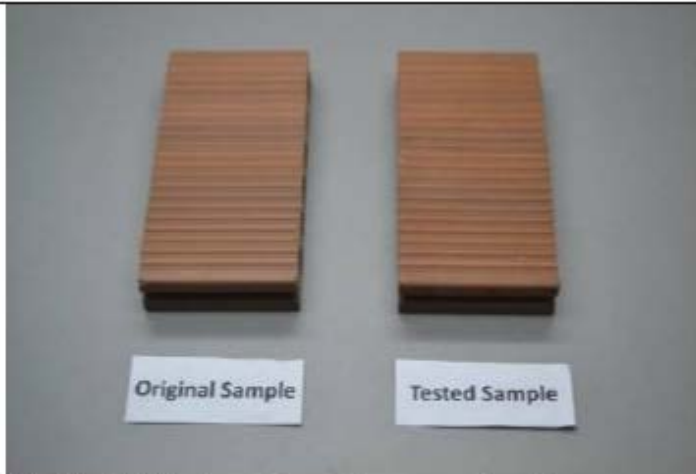
Model: UH07, Part showed some color change. There was no other visible surface damage. After 3000 hours test, $\Delta E^*=3.64$ Gray Scale 3.

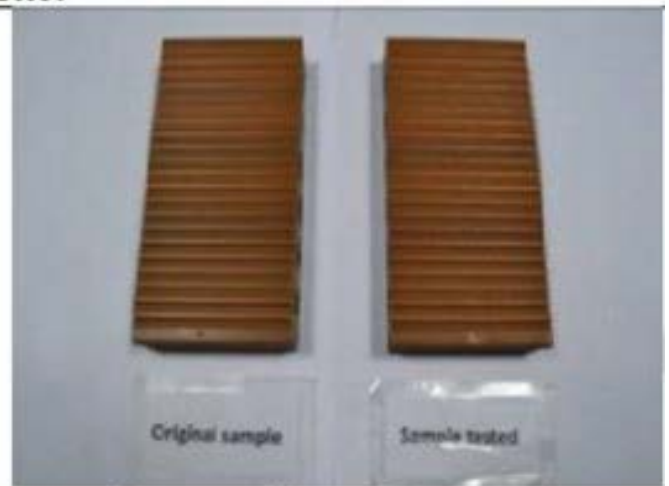
Model: UH07

After 1000 hours test, Grey Scale 4-5, $\Delta E^* = 1.41$

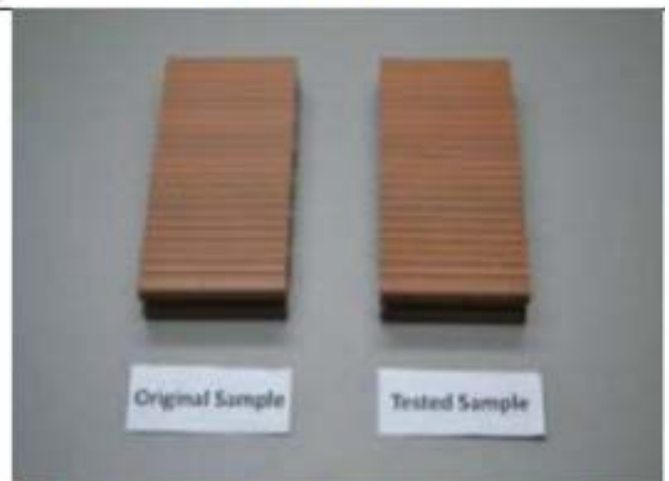
After 3000 hours test, Grey Scale 3, $\Delta E^* = 3.64$
