# Why NewTechWood® with UltraShield?

v20200610 AUS

# UltraShield® Advanced Capped Composite Material

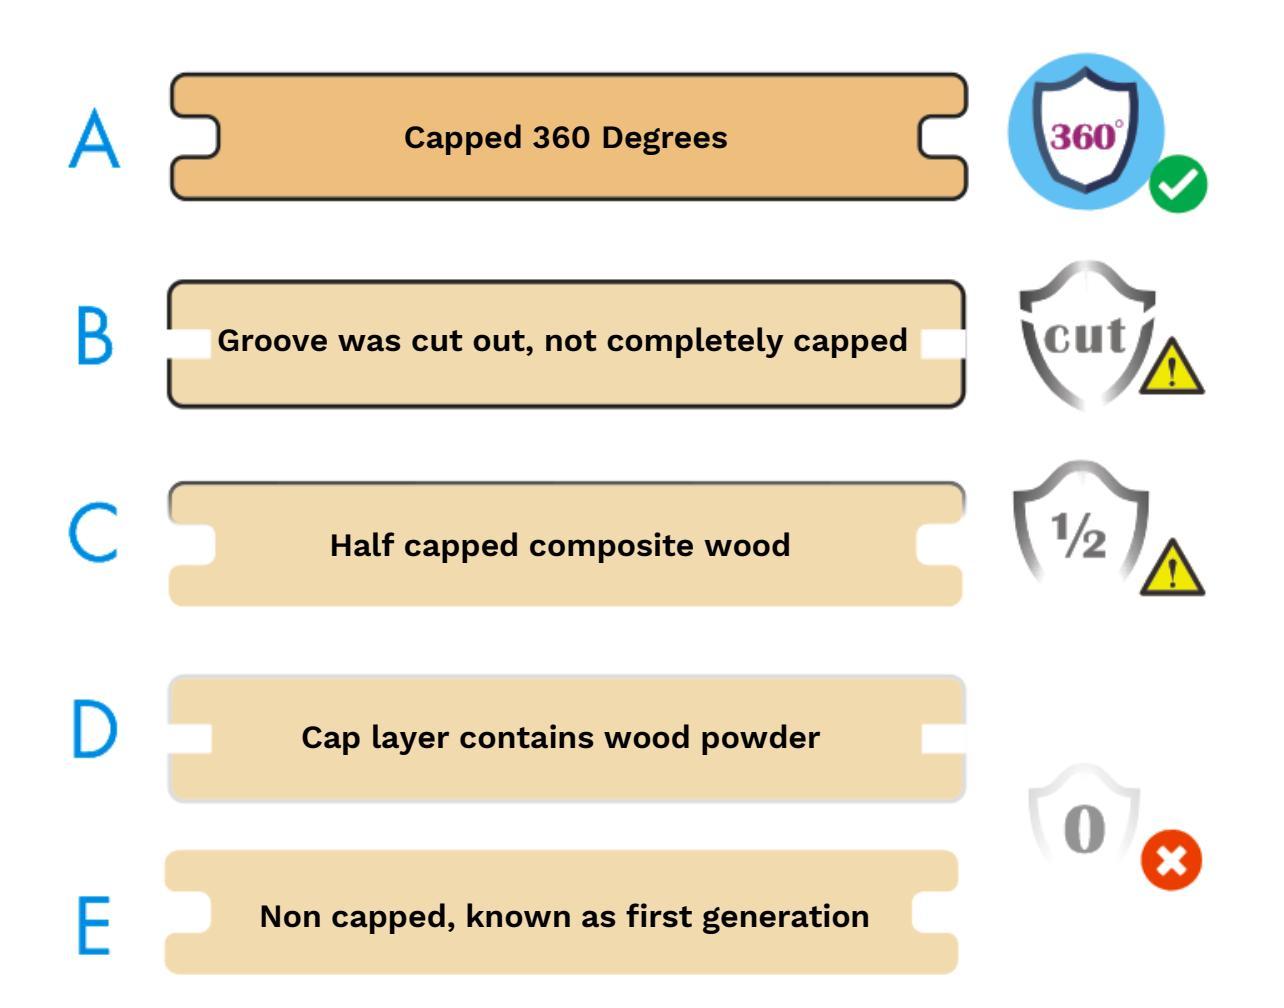
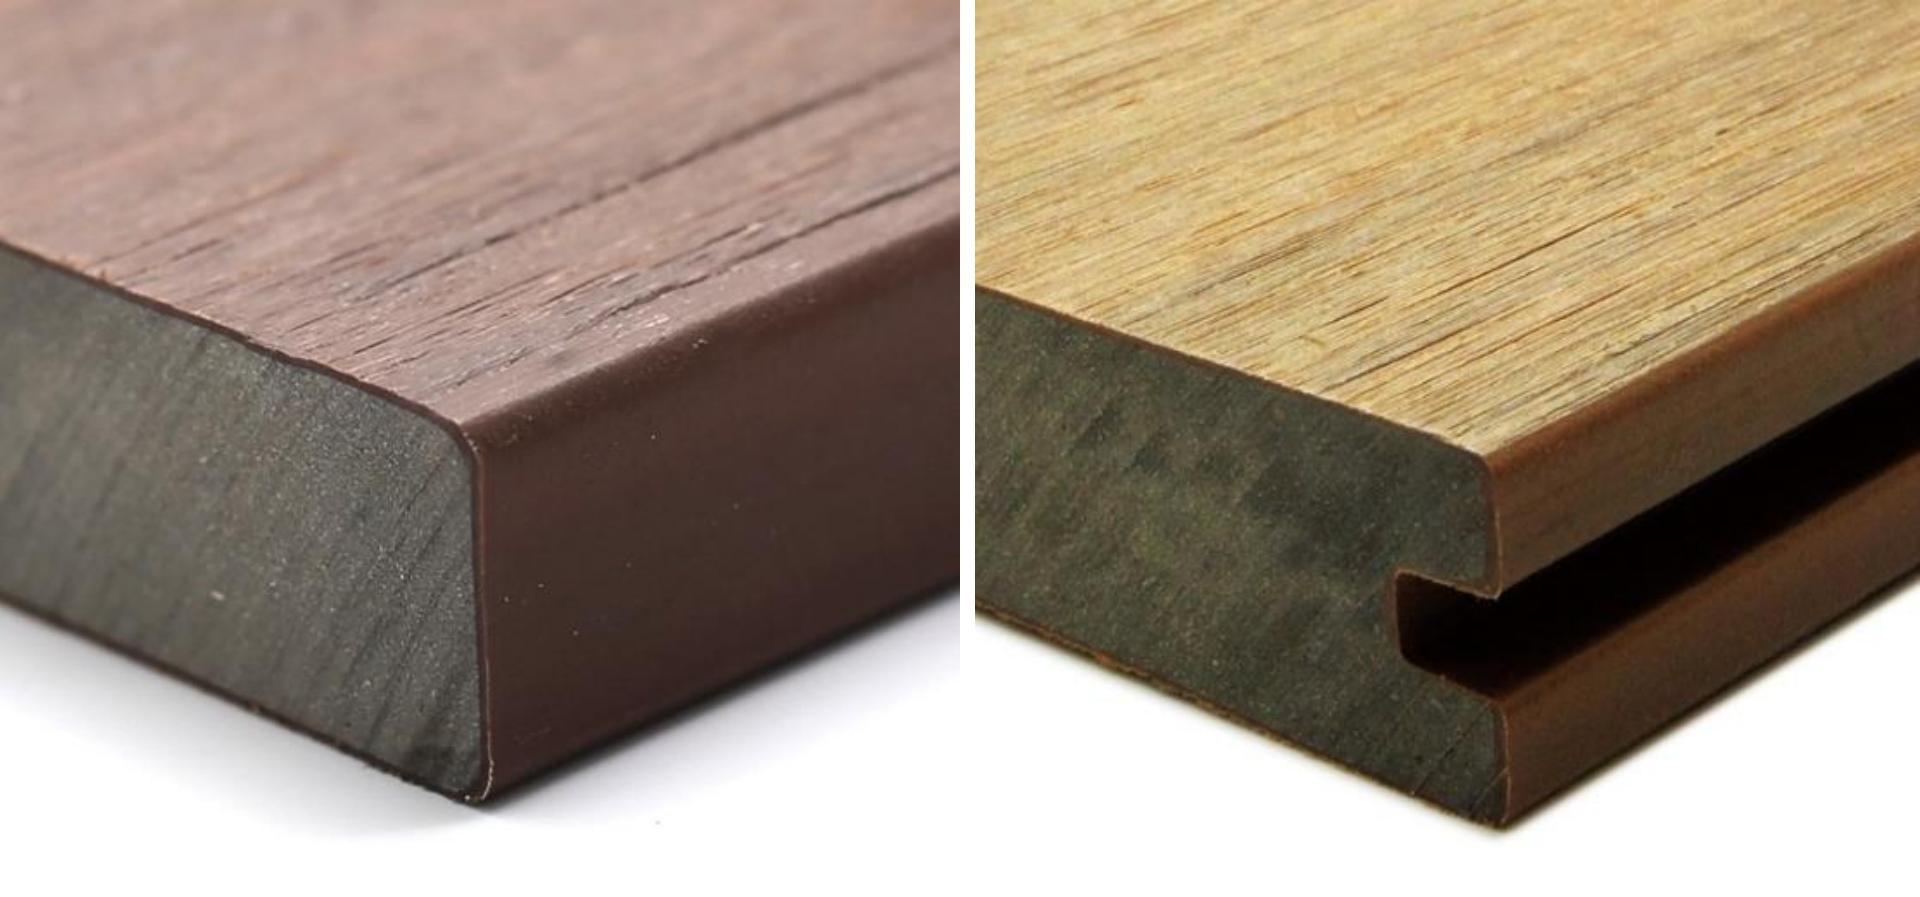
Based on PE composite wood market, they can be divided into capped and non capped composite wood. Five different types of composite wood can be identified as follows.

Picture shown: Type A: 360 degree completely capped, including groove

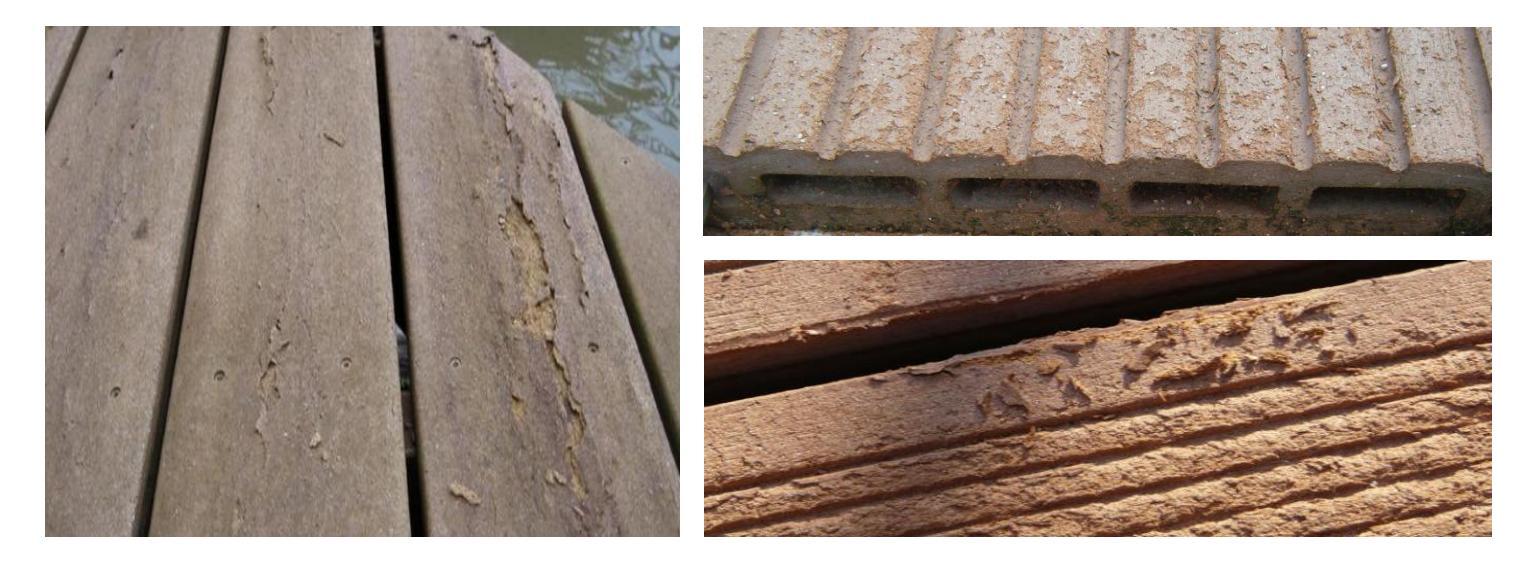
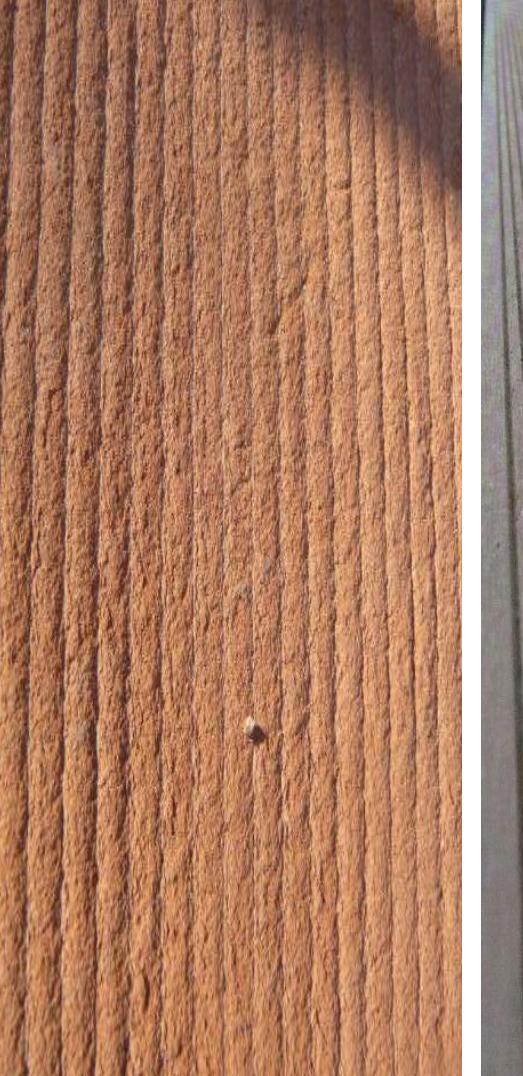
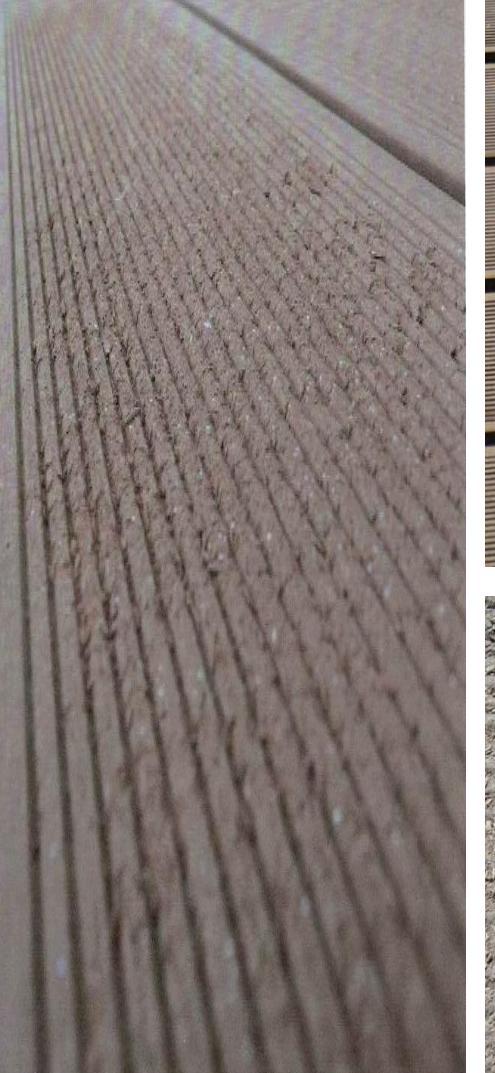
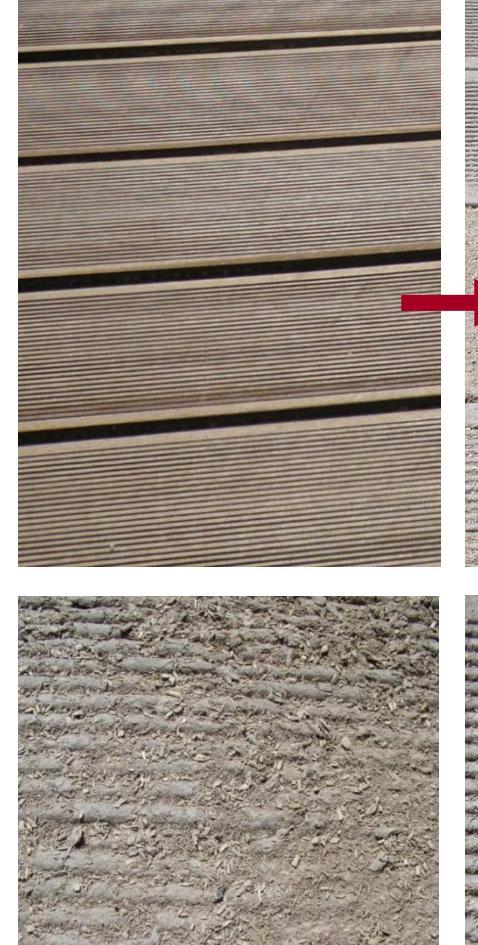
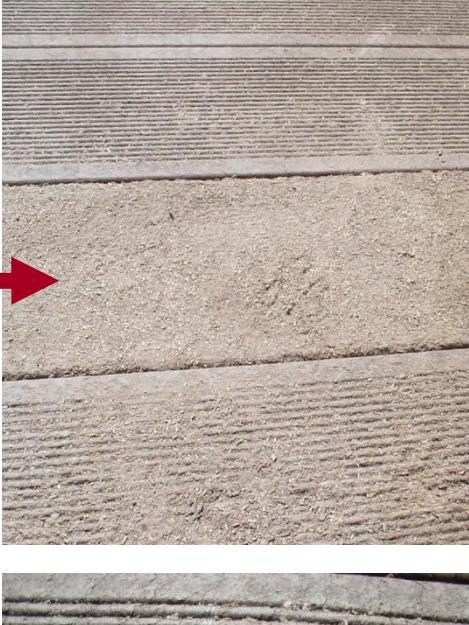
# 1. Crumbling

• When the first generation composite boards are exposed to the UV and water, it begins to decompose. This is due to an improper amount of bonding agent and antioxidant added to the composite material.

Ultimately, the wood fibre absorbs moisture with UV together which causes composite decking to decay, crumble, deteriorate and rot.

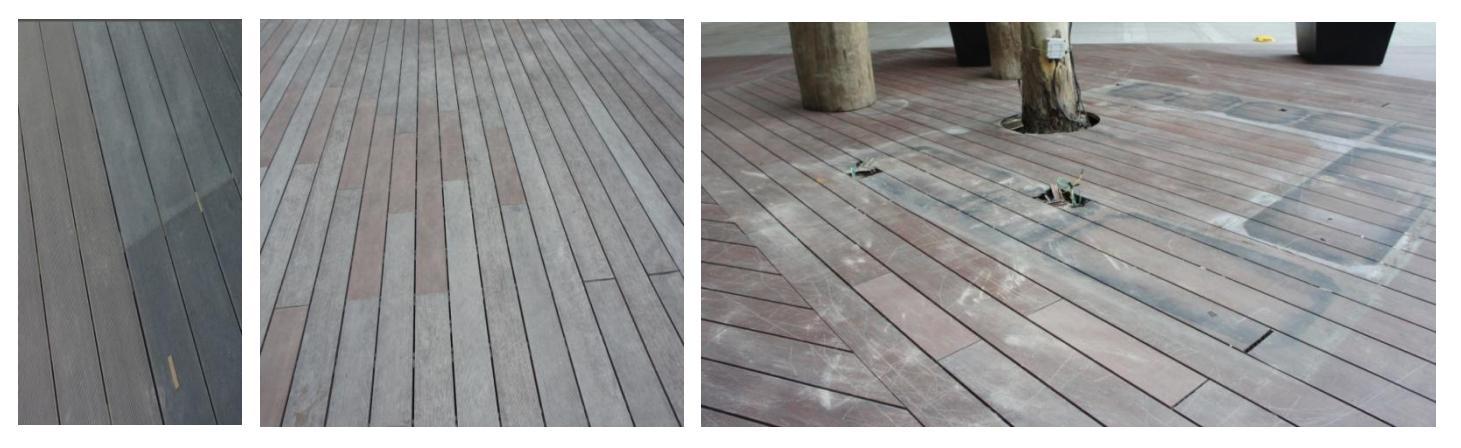
# 2. Colour Fading

• The reason for colour fading comes from the wood fibre content. Wood naturally fades if not protected. Most of the time manufacturers brush their boards which damages the plastic, allowing the wood fibres to be exposed to the surface. Inconsistent fading occurs due to the manufacturer's inability to control the consistency of the colourant and raw materials being added.

Colour difference - many decks were faded with uneven colour resulting in some boards being lighter and others appearing darker.

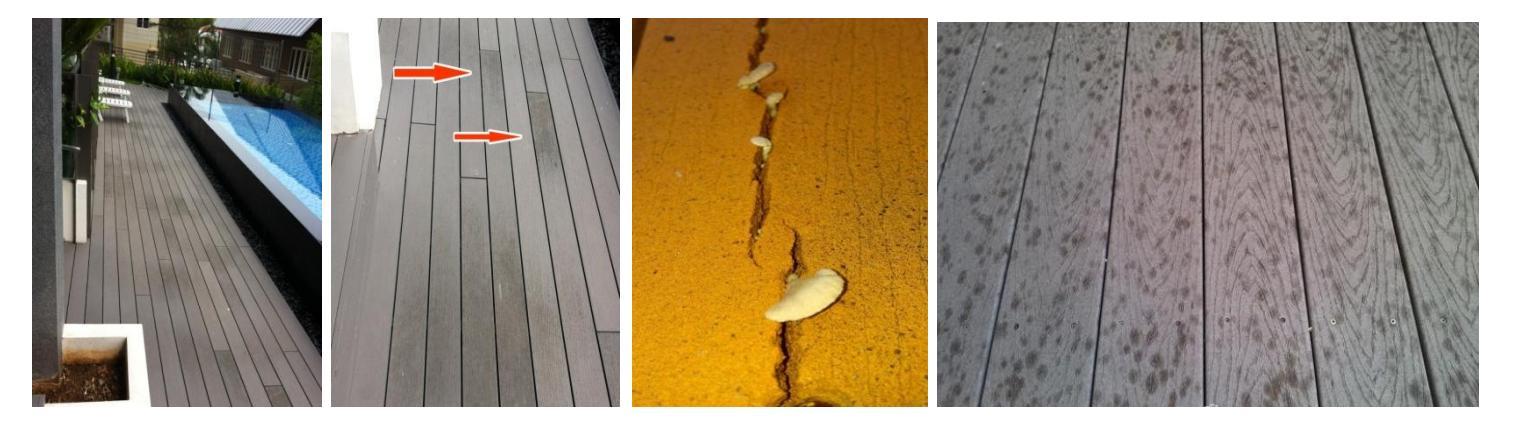
# 3. Fungus, Mould, Mildew

• Fungus, mould, and mildew problems are usually found in climates with extreme humidity or climate change. When not protected by a sealant or treated, the wood fibres are attacked when they are exposed to the elements.

Many people have tried to use deck cleaners to clean off the mould, but once the layer that is sealed/protected by the cleaner wears off, the mould will just attack the other layers below.

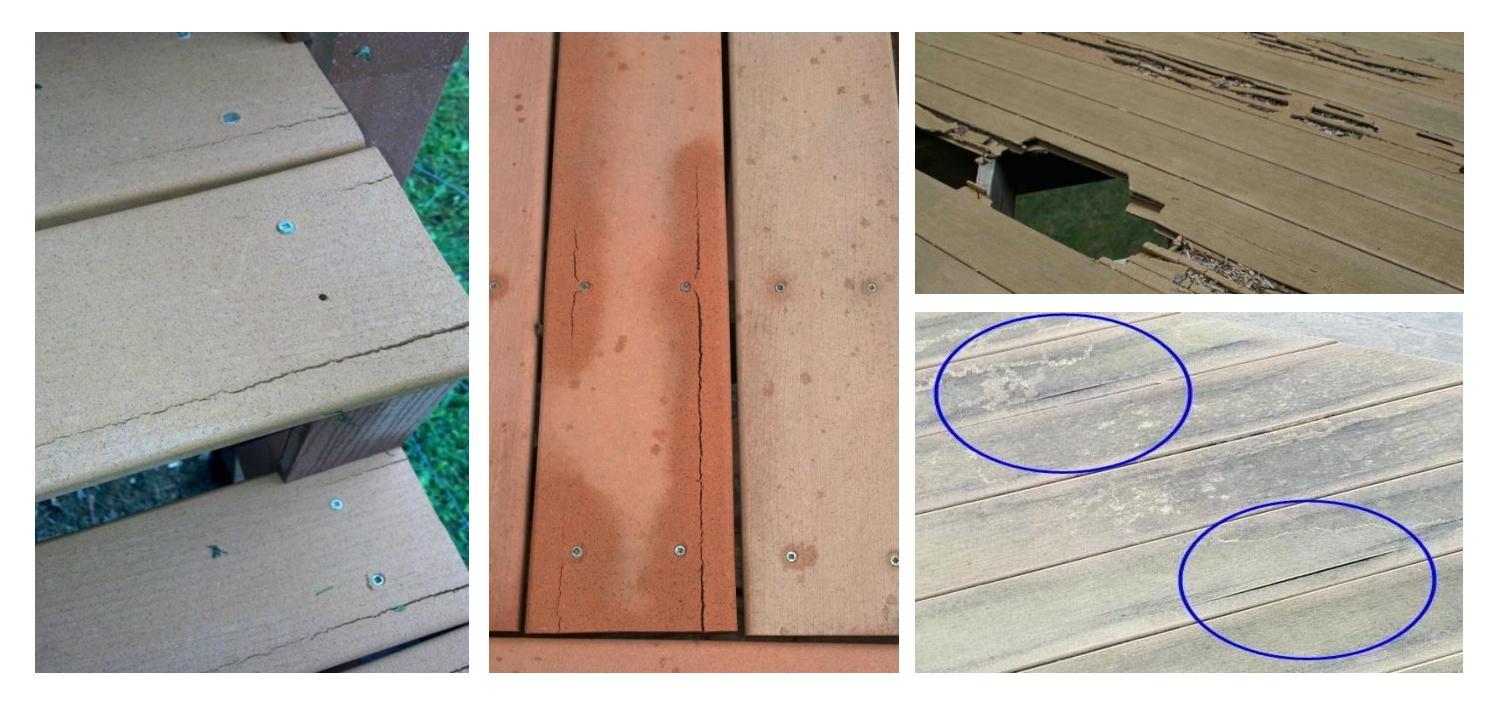
# 4. Cracking

• Many manufacturers add calcium / filler to their product to enhance the stiffness of the board, but it makes the board more brittle. Therefore, when installers try to drill into the board there is a potential that it might crack.

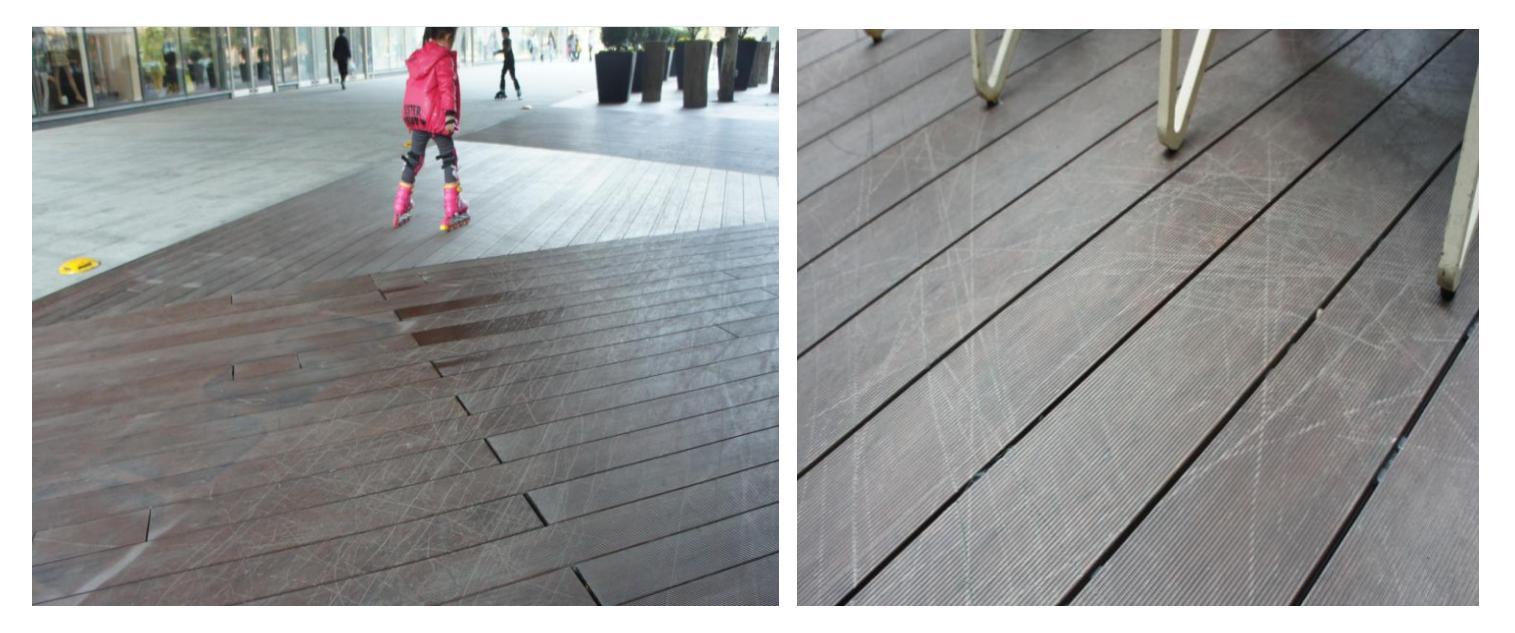
# 5. Scratching

• The first generation composite's scratch resistance is very poor and this is due in part because of the wood fibres. Wood fibres inherently have a low scratch resistance and when the manufacturer brushes/sands the board, it creates a coarse effect on the surface, allowing for even less scratch resistance.

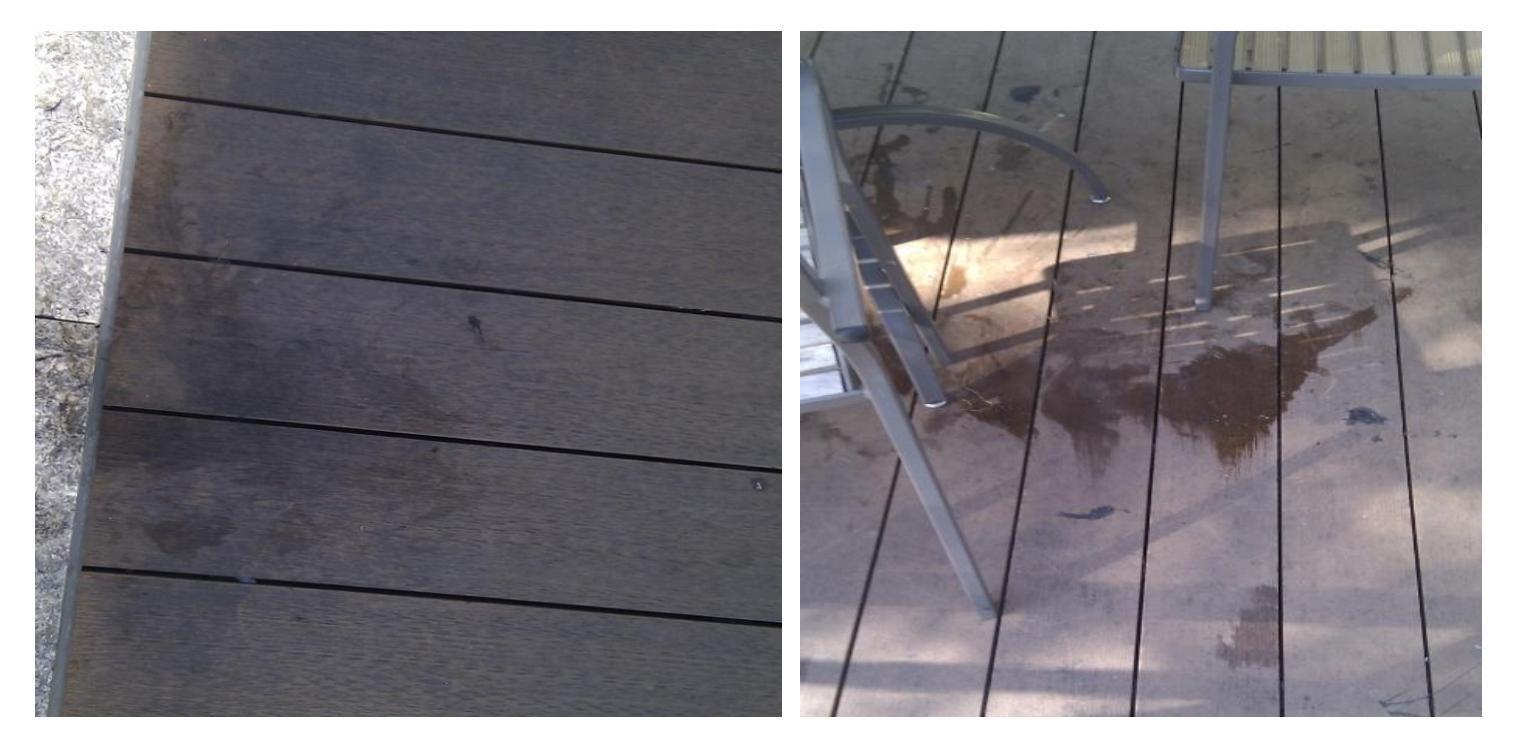
# 6. Staining

• Without any cap protection, any stains will be absorbed by the wood fibre or penetrate in between the wood fibre and polymer directly and permanently.

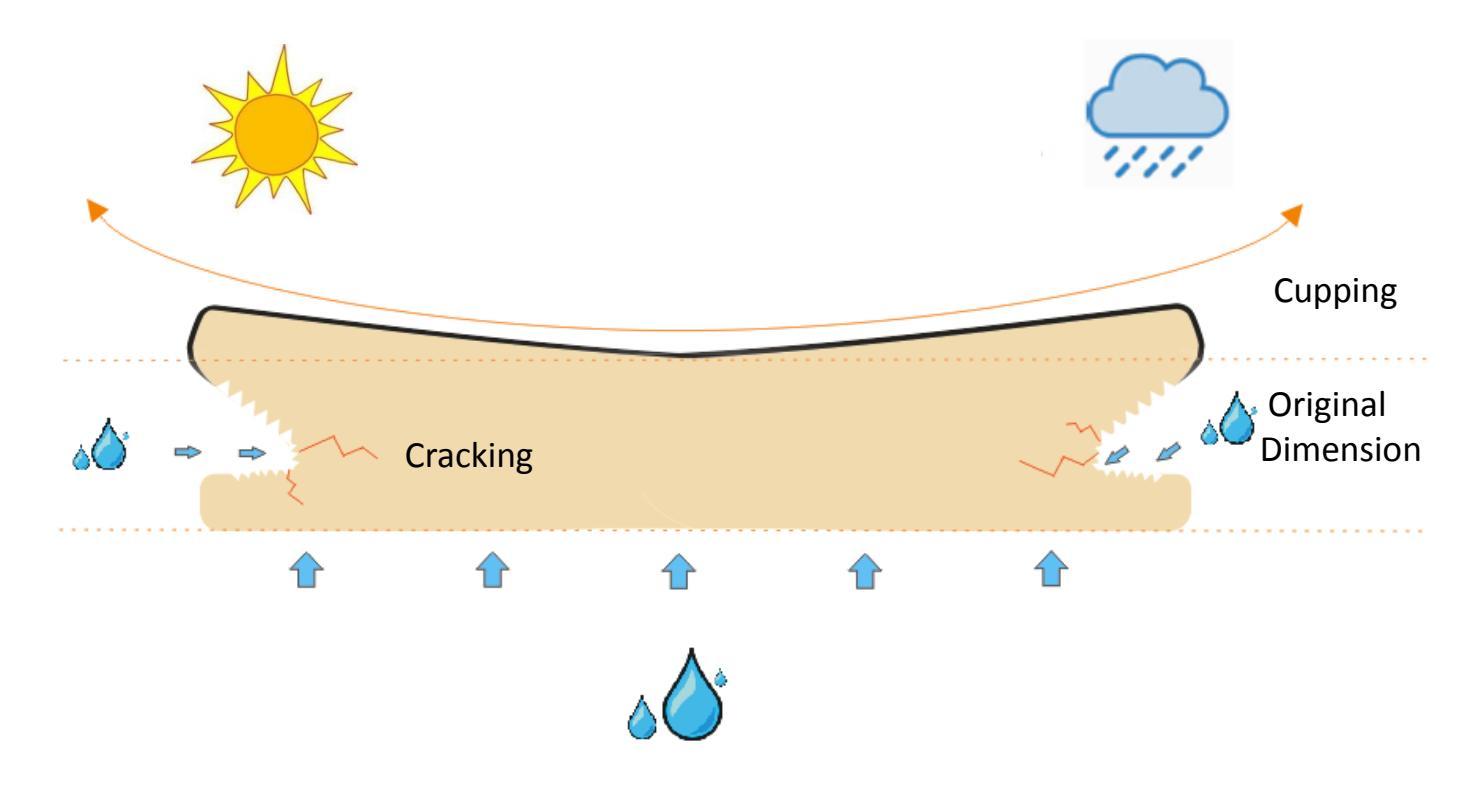
# 7. Swelling & Cupping

- The shield uses a virgin engineering grade polymer that has an extremely low water absorption rate. The shield on a half capped board is only protecting the top, meaning that the bottom is still exposed in a similar fashion as the first generation composite.
- Therefore, on a very humid day, the bottom will continually absorb moisture and the top will be almost completely dry. This creates a cupping/ twisting effect on the board similar to real wood. The force of this effect can be so strong that it actually tears/splits the core in half as shown below.

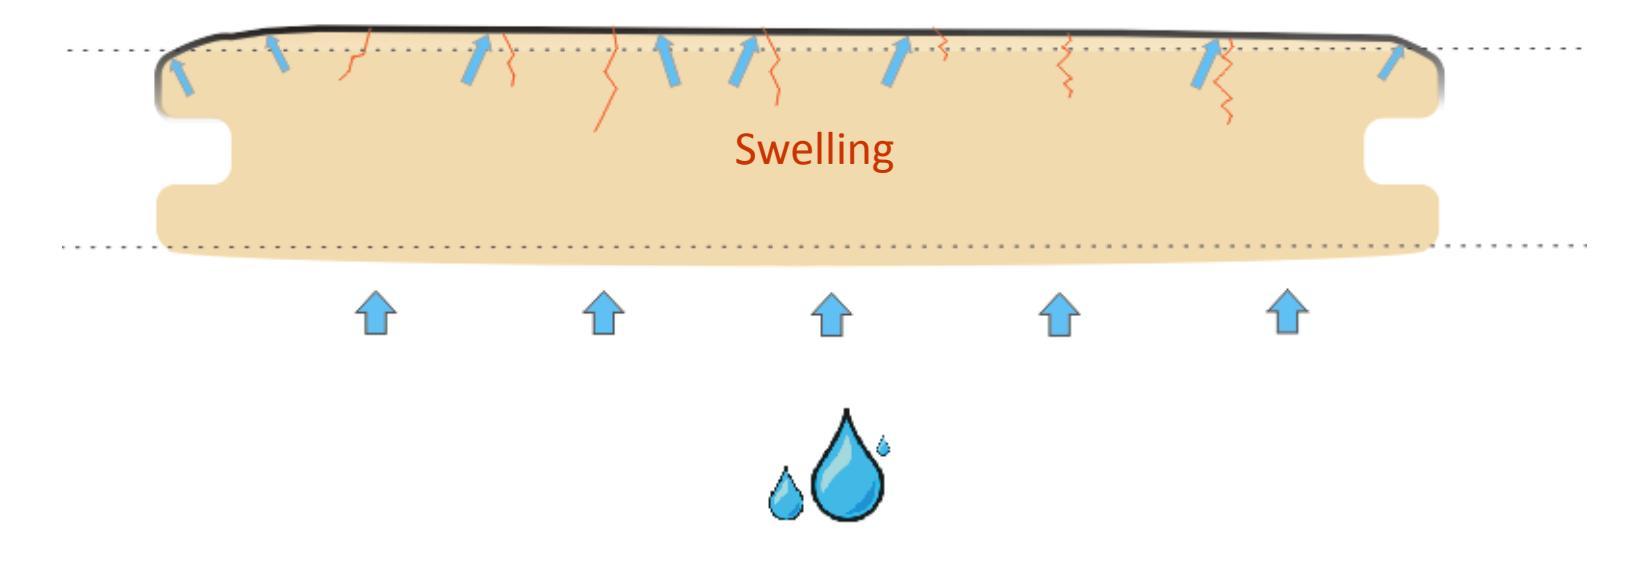
# 8. Cracking in the cap layer

• As the inner core continues to gain moisture, the force could get so strong that it tears the cap layer as well.

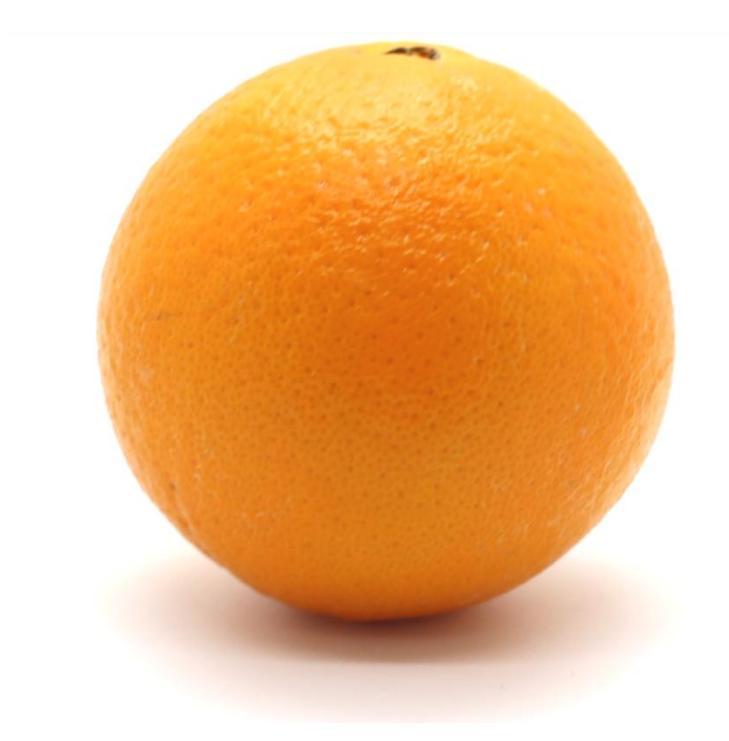
Groove was cut out, not completely capped

• A board with an uncapped groove still allows moisture to be absorbed into the core through the entire length of the board. Therefore, there is a potential for swelling, cupping, and cracking to exist over time.

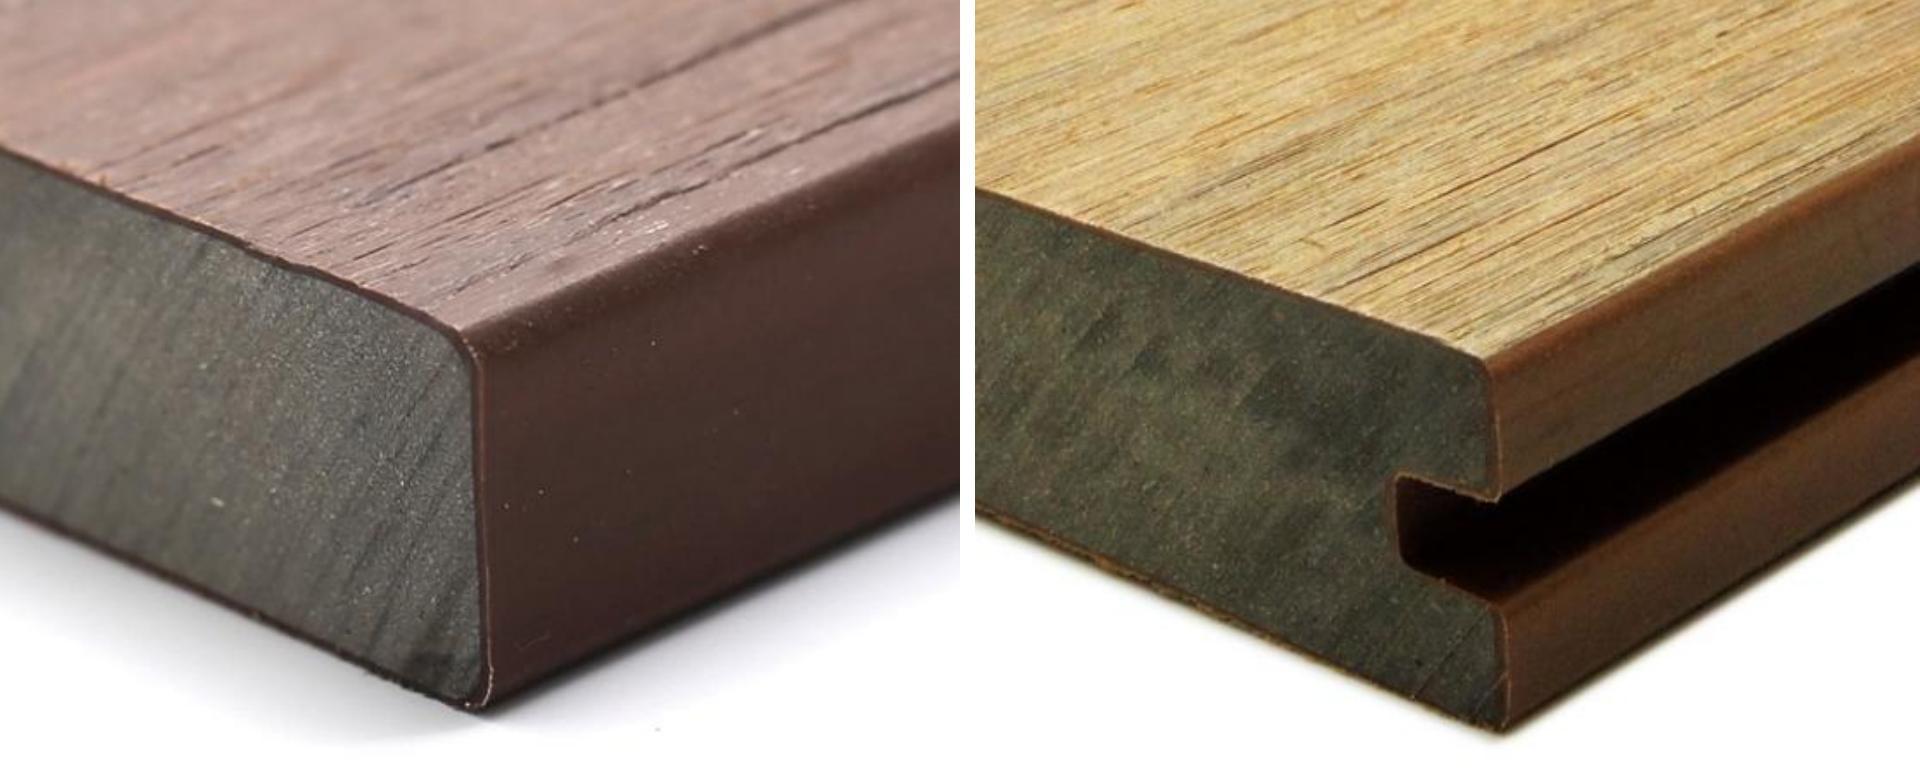
360 degree capped shield!

Capping 360 degrees provides complete protection all around the board and even in the groove of the board. This is the only way to completely protect the board from UV, water, insects, and any other mould/mildew from attacking the core.

Note: The core is still susceptible to the outside elements, so it is recommended to either use a sealant or end caps to cover up any ends that are not protected.

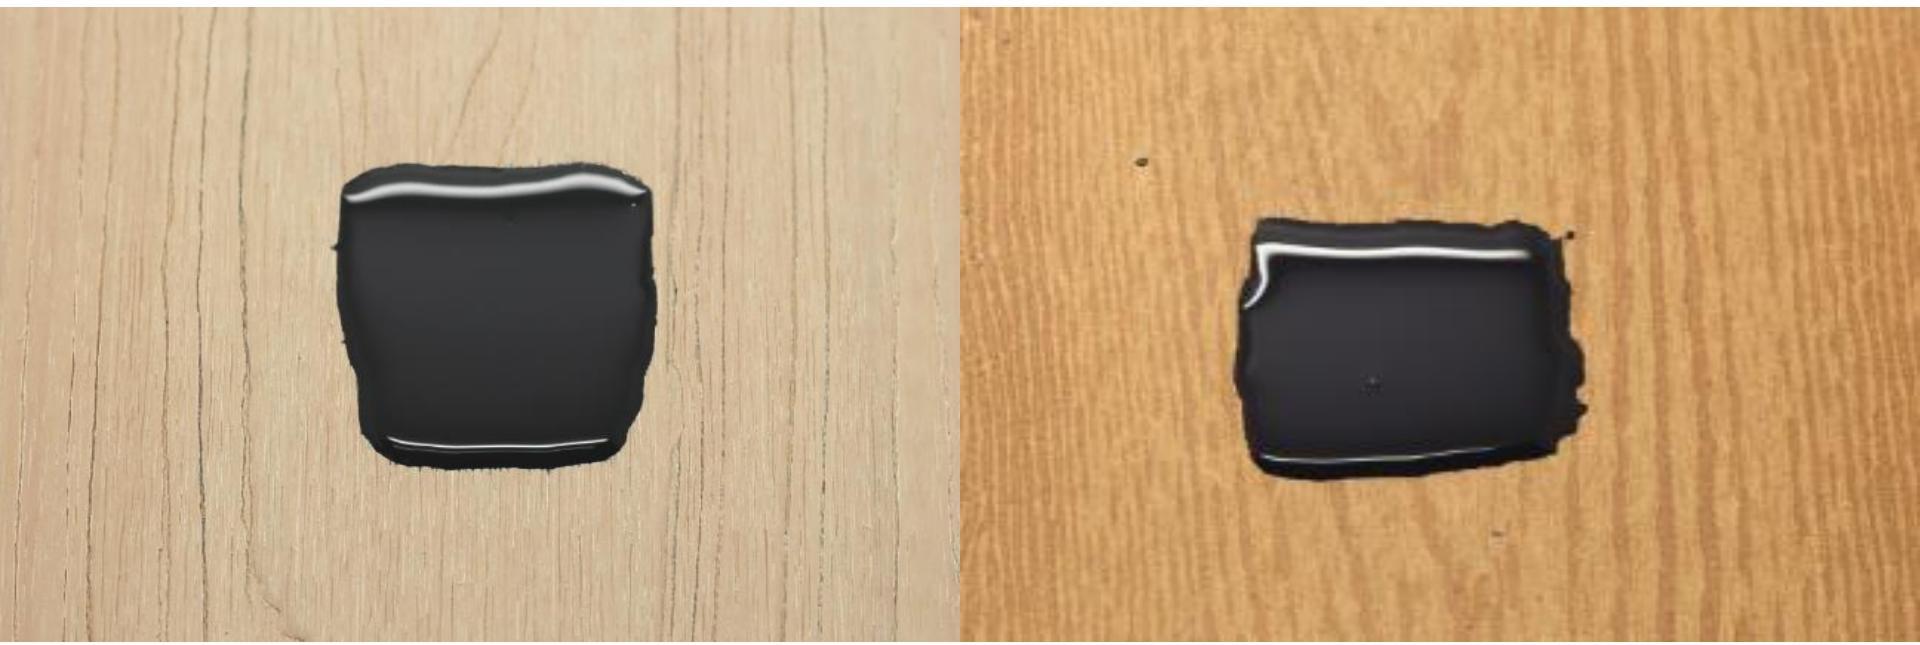
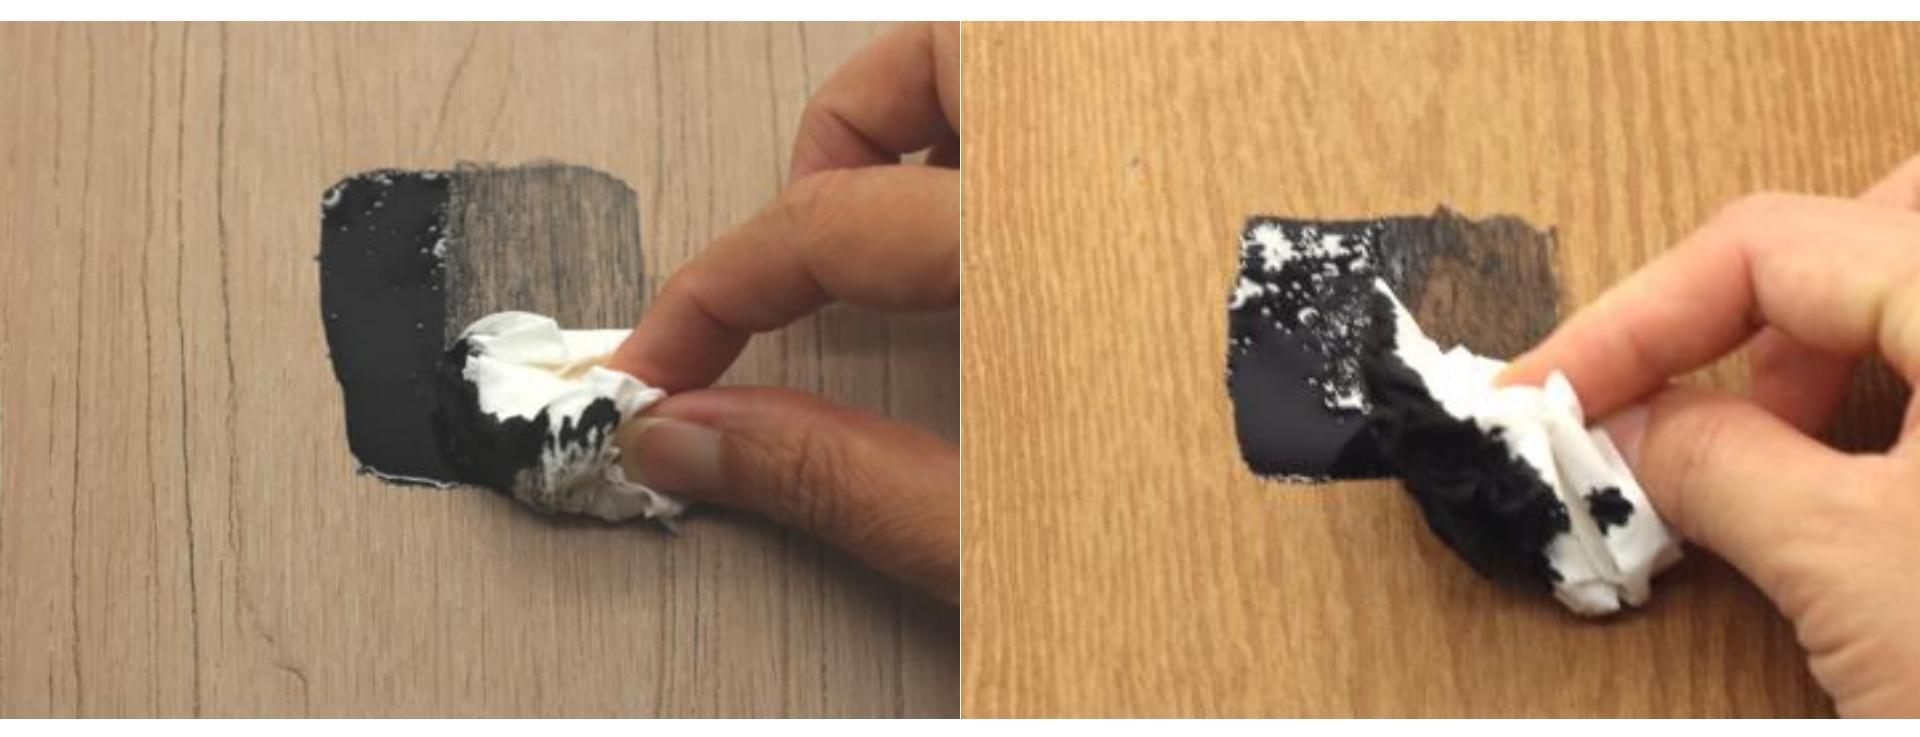
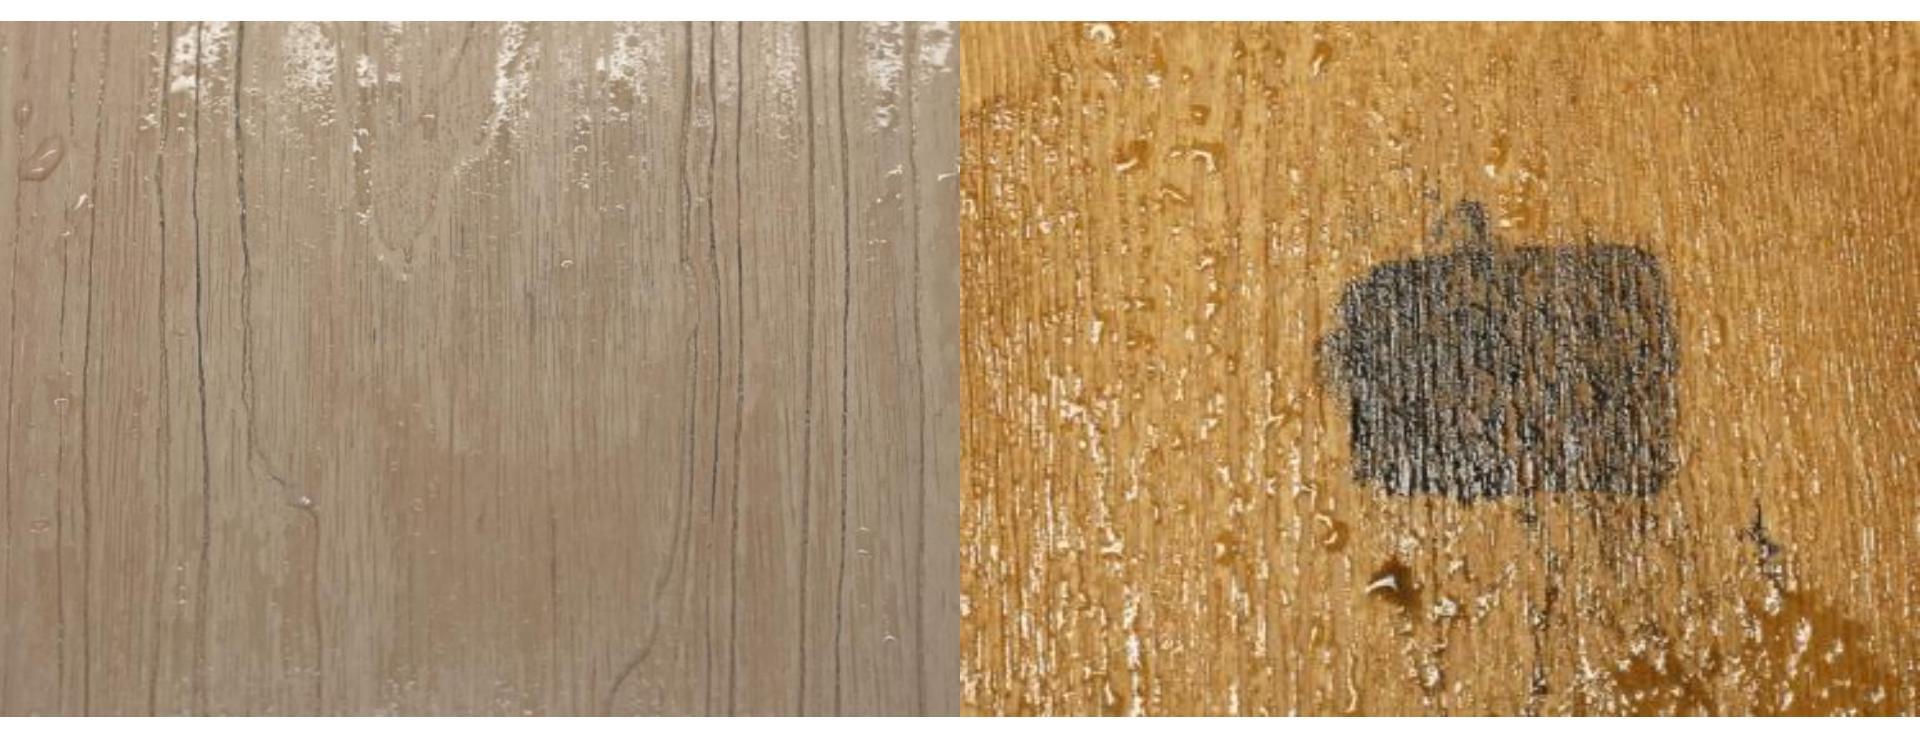
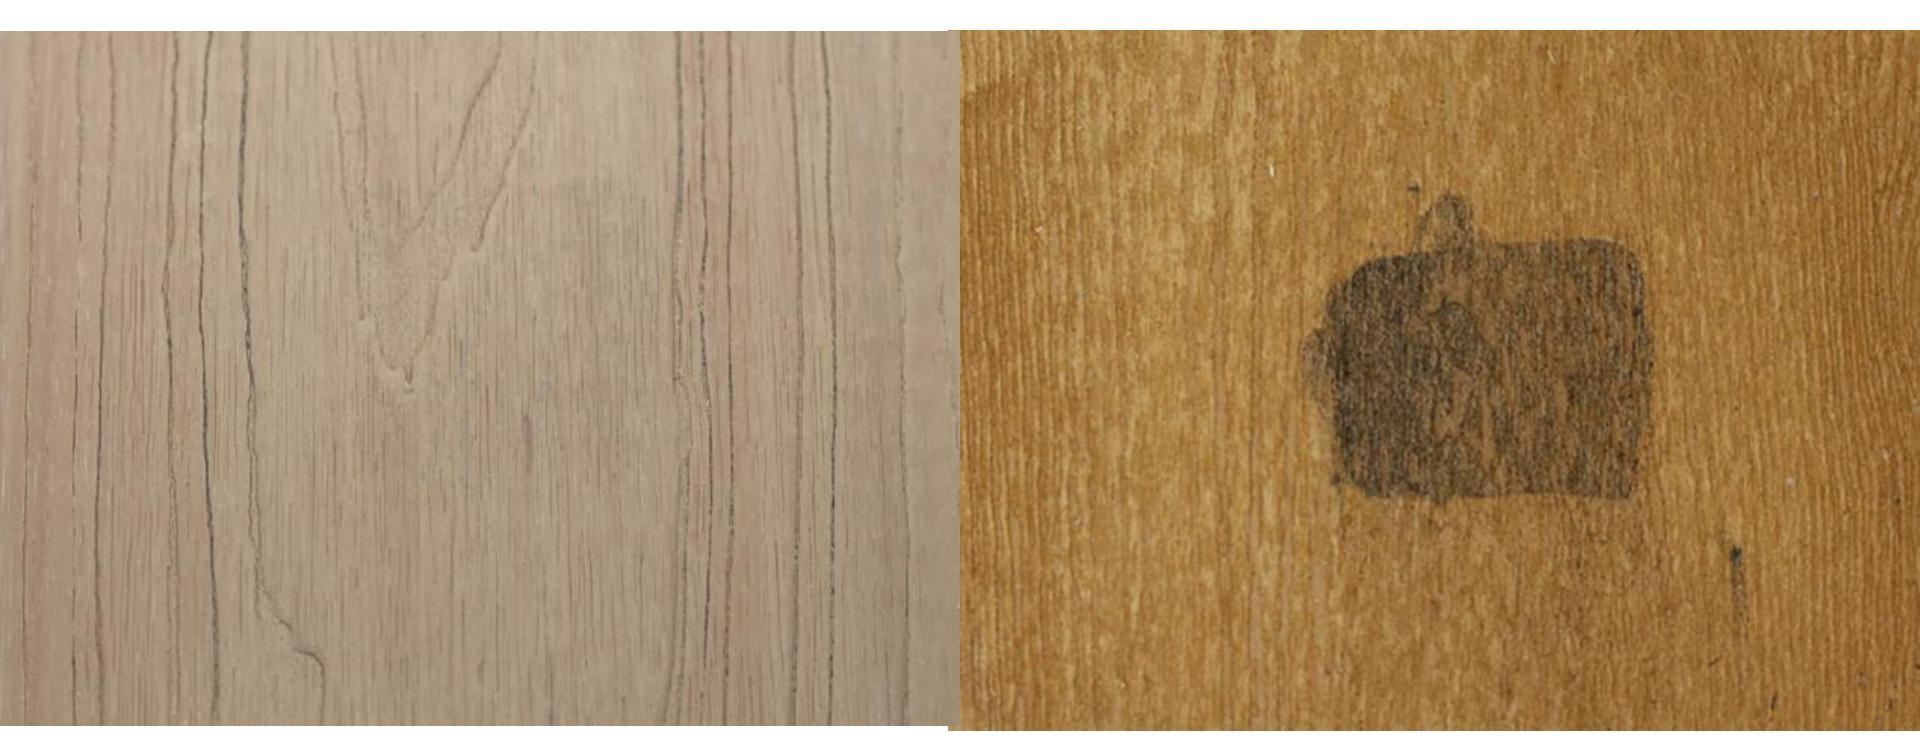
# 3.1 Stain Test

### Wipe off half of the ink

**UltraShield<sup>®</sup>:** No penetration through the top layer and no stain left
