# Why NewTechWood® with UltraShield?

v20200610 AUS

# UltraShield® Advanced Capped Composite Material

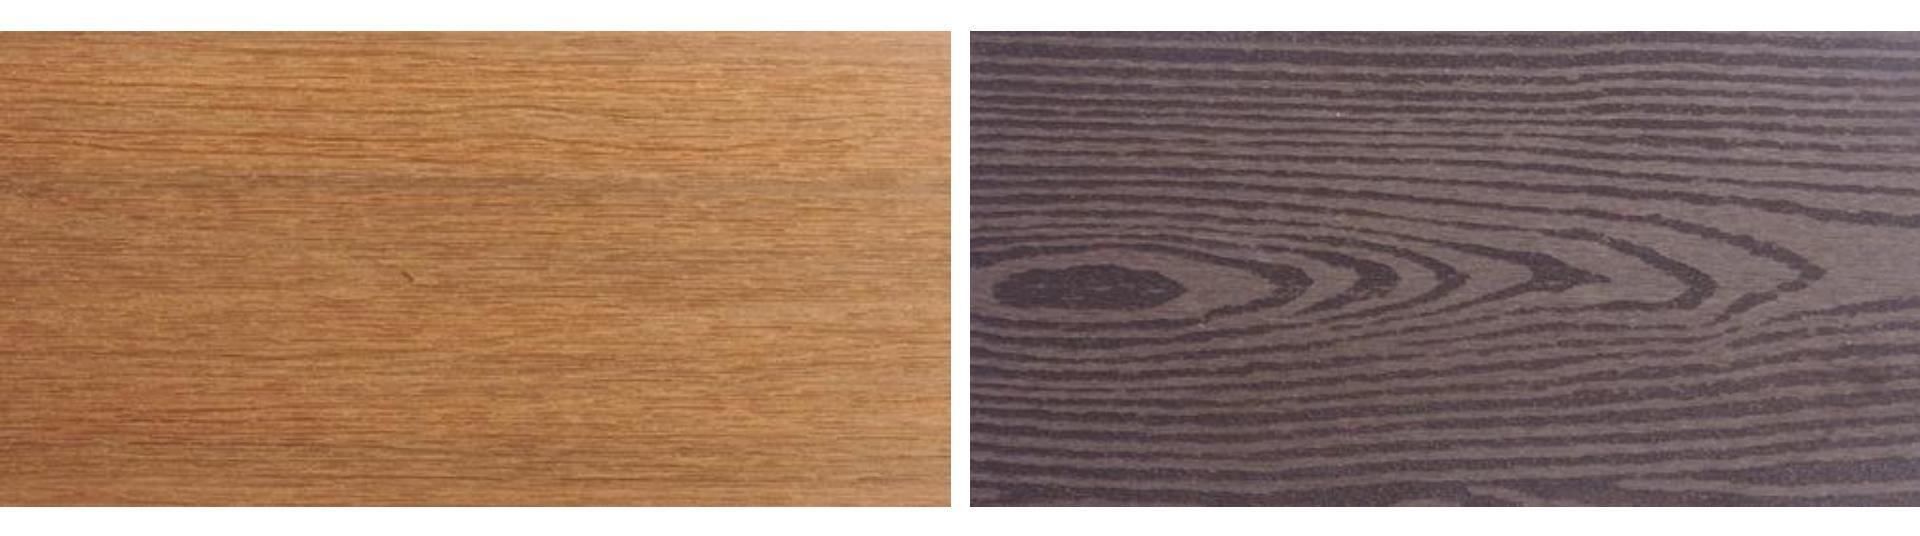
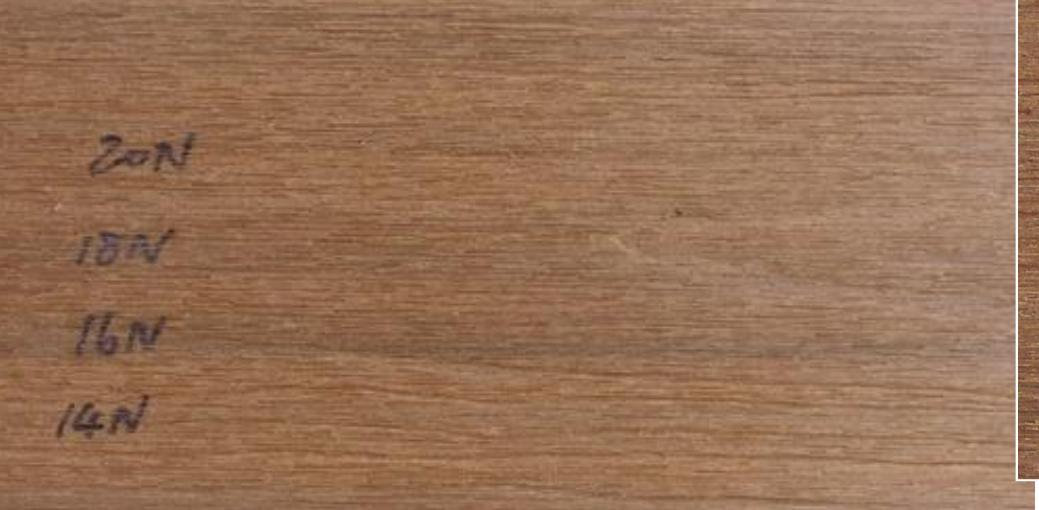
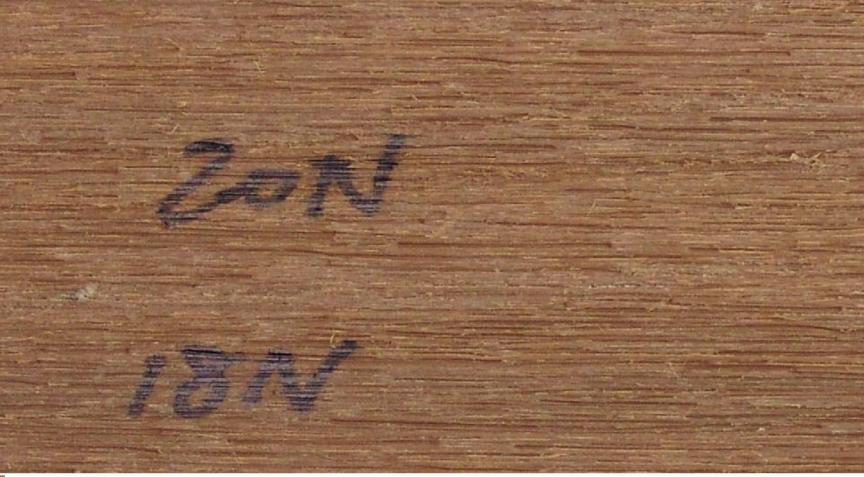
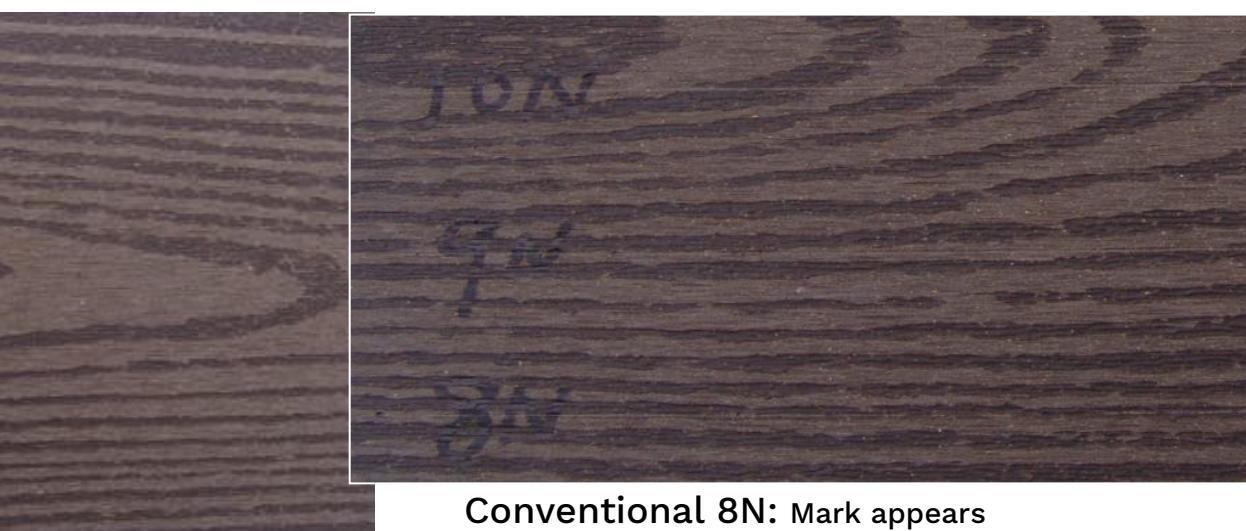
# 3.2 Scratch Test

- Use 1 mm needle
- Test scratch damage under 8N-20N pressure
- Test Standard: FLTM BO 162-01

UltraShield<sup>®</sup> 20N: No obvious mark

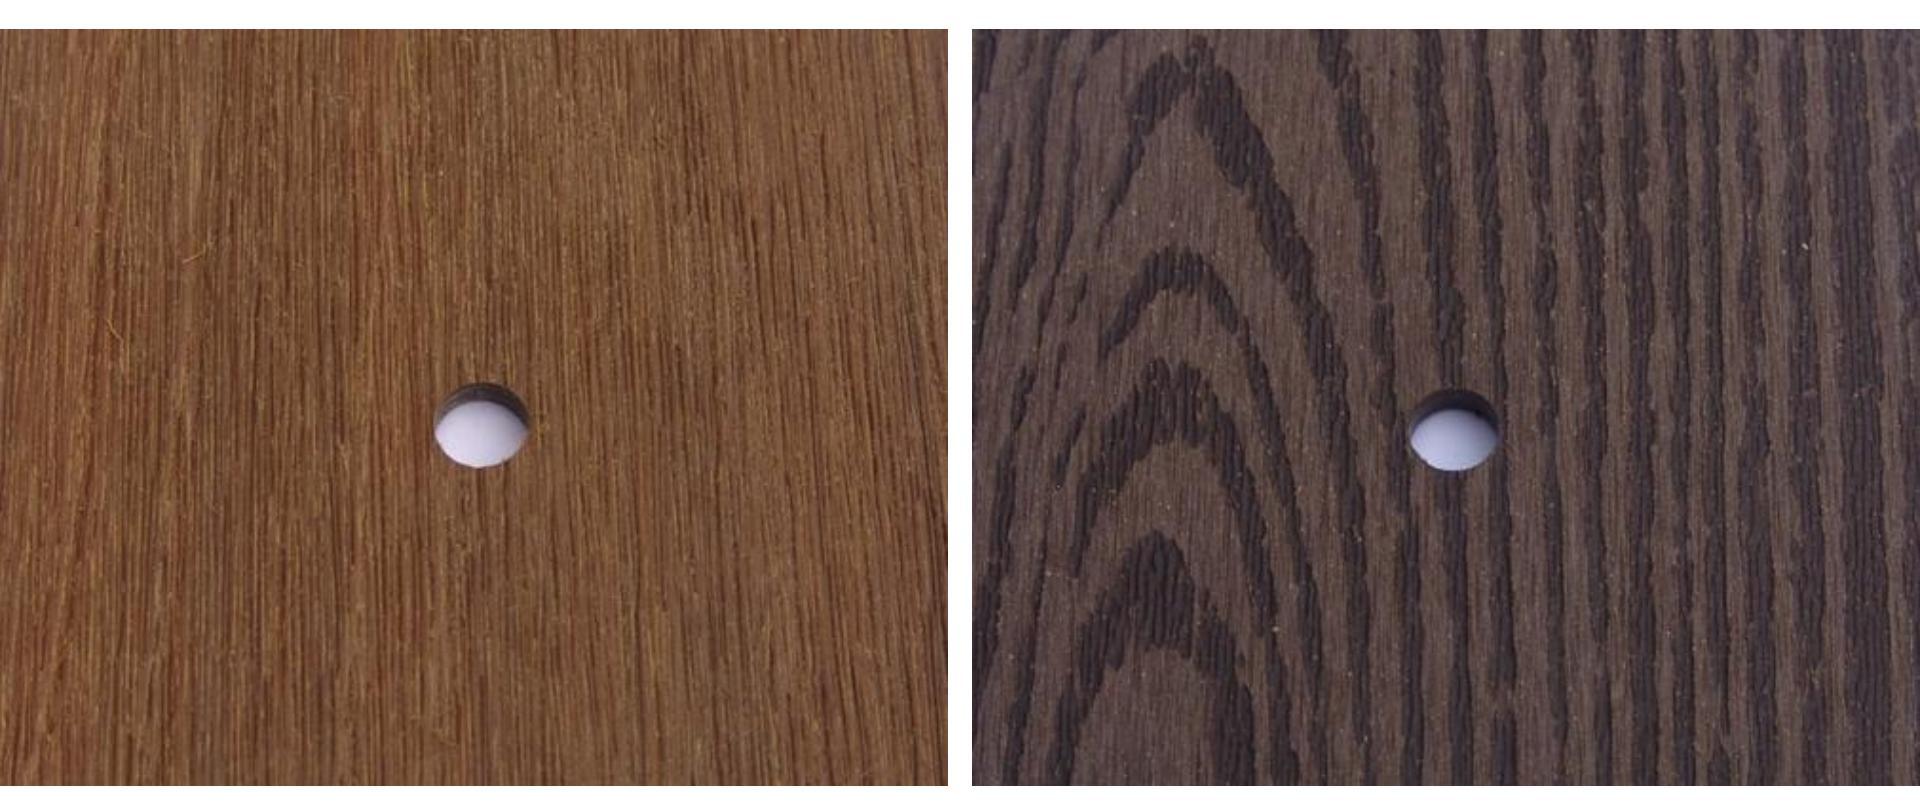
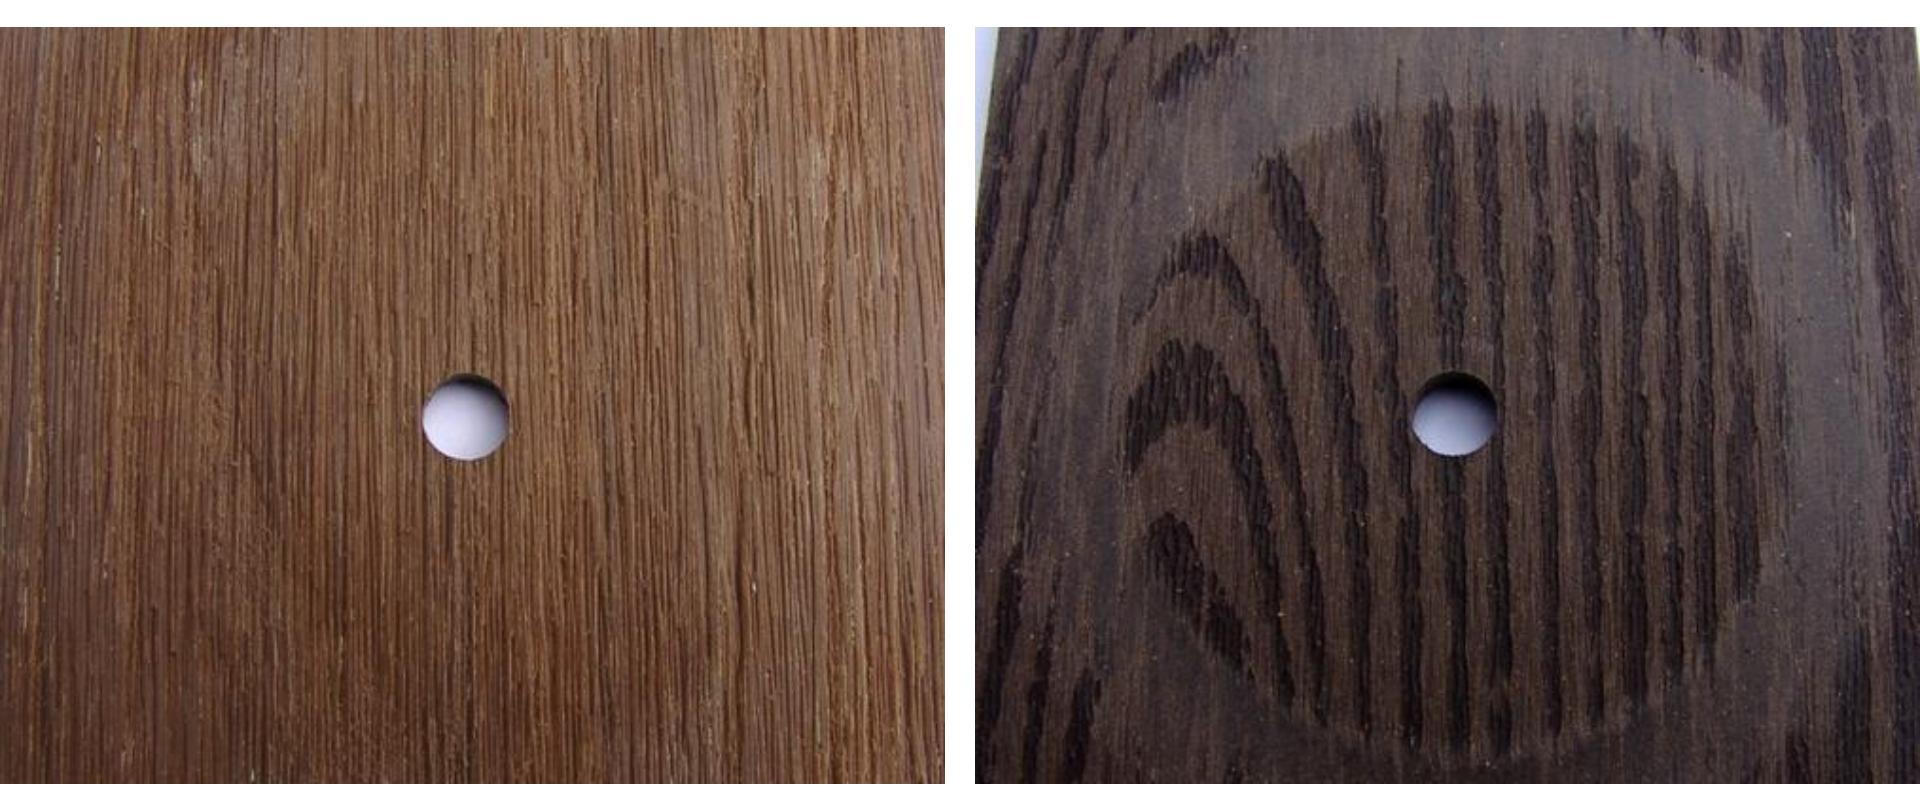
# 3.3 Abrasion Test

- Testing: 750g Weight,60 turns/min, 1000 turns
- Test Standard: ASTM D4060

#### Scratch mark and the wore off powder weight after test

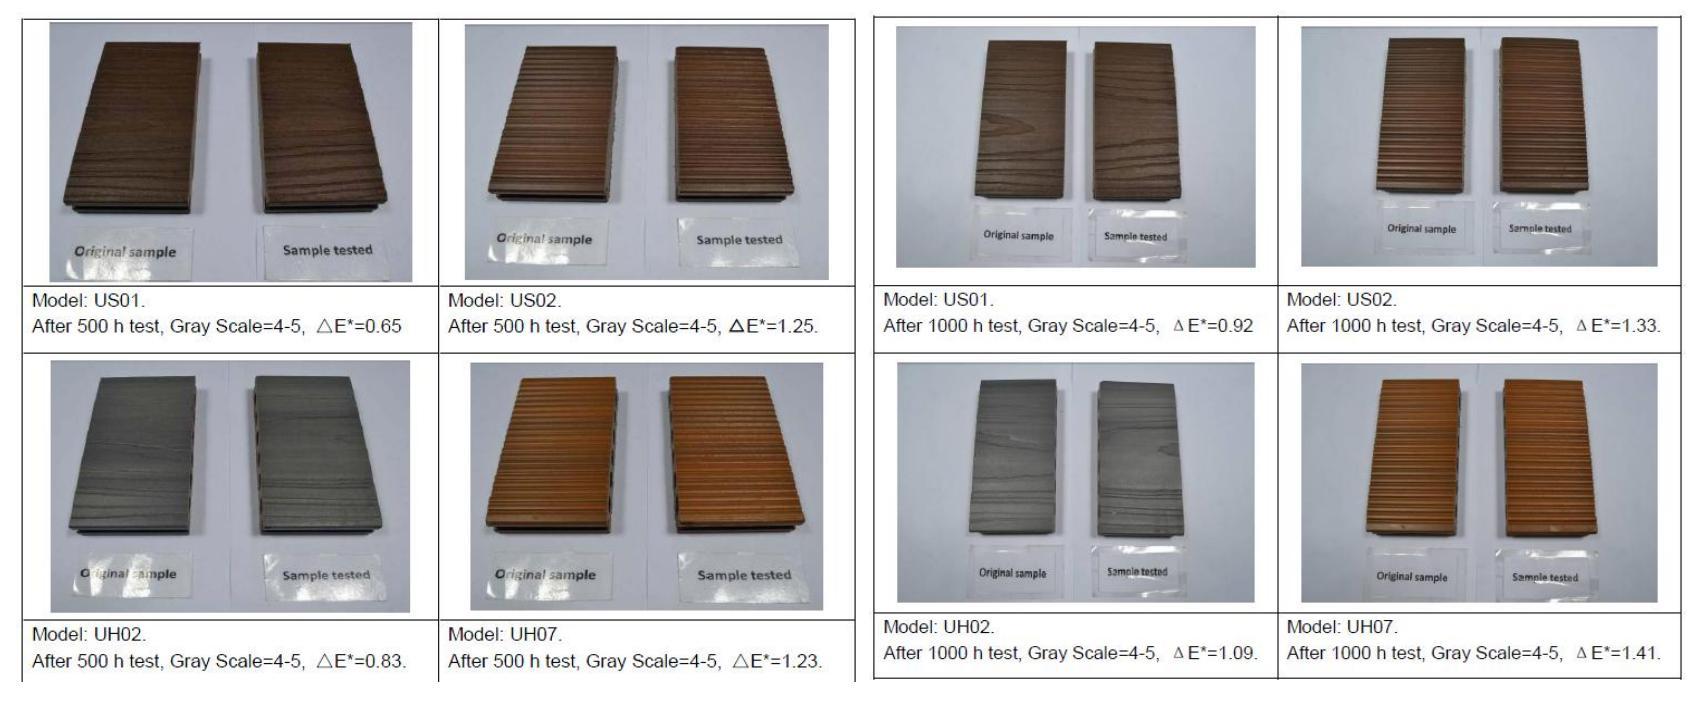
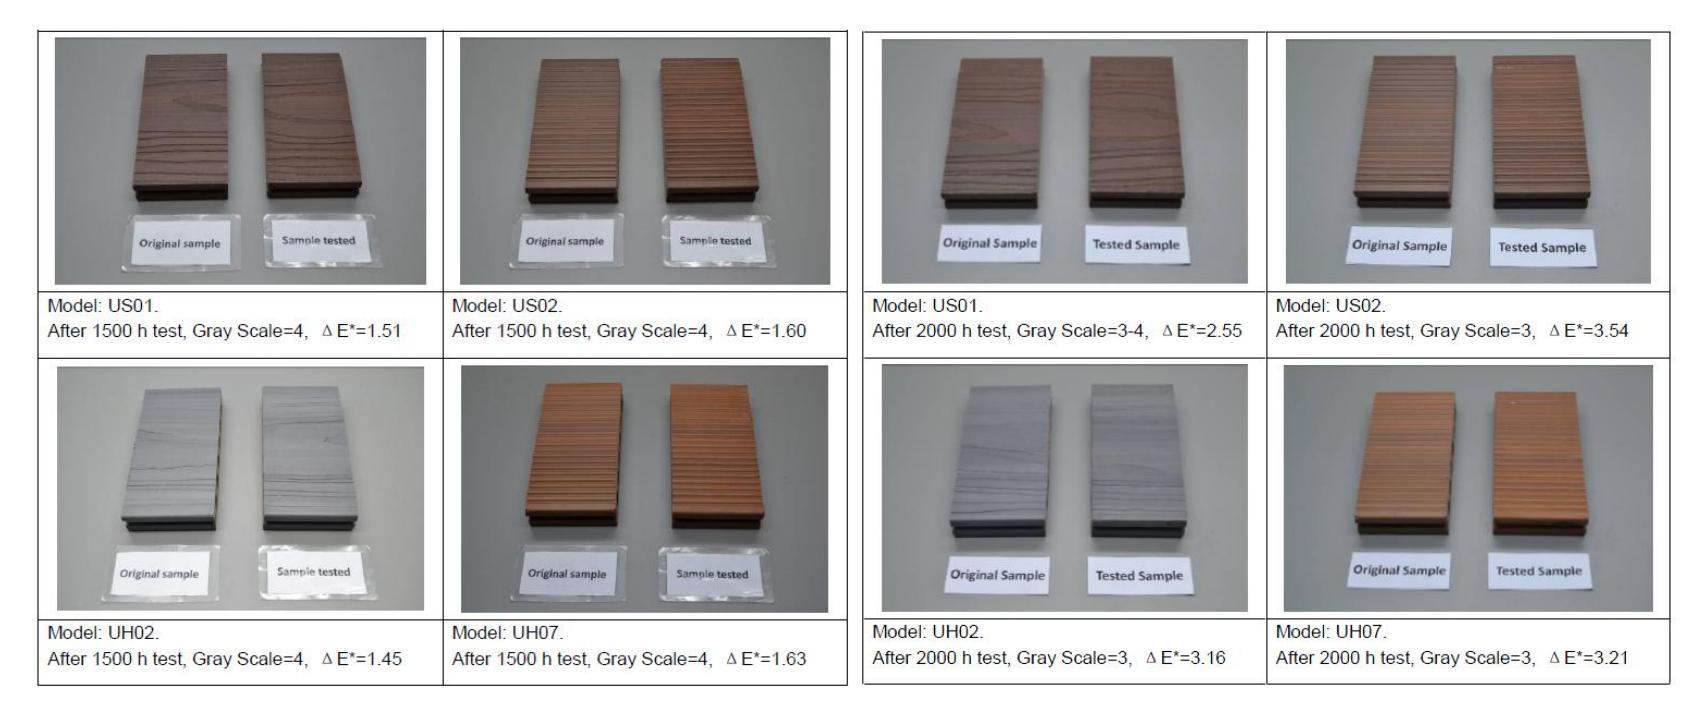
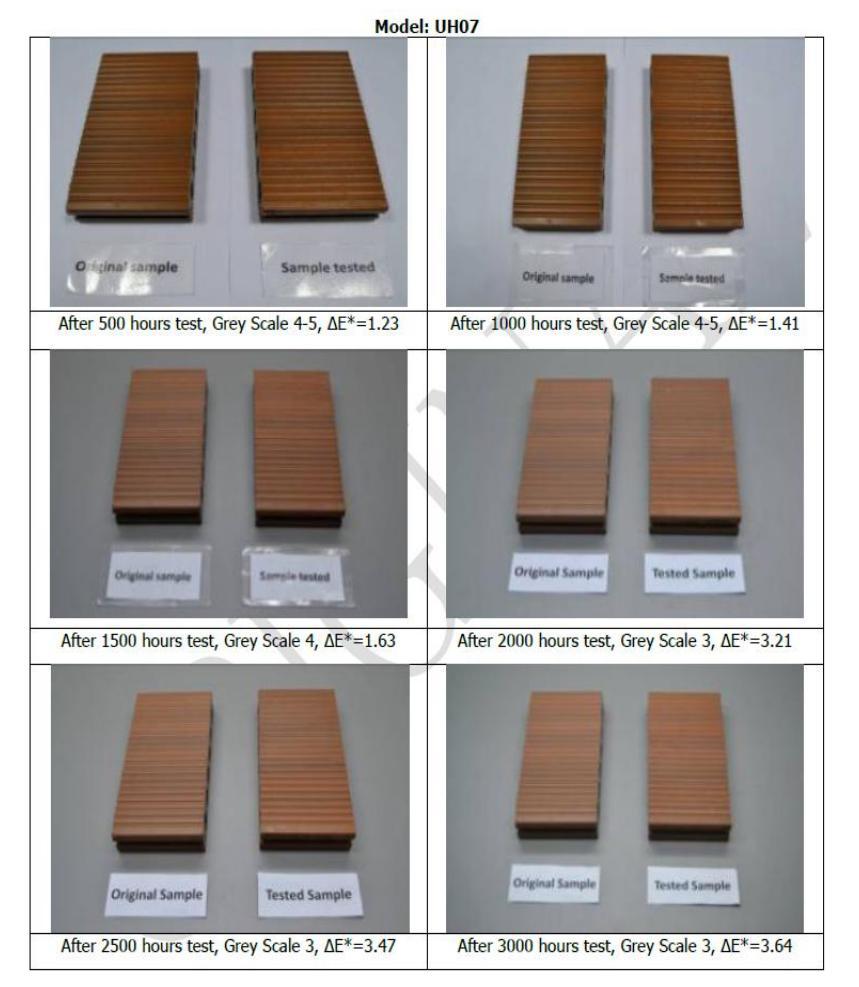
# 3.4 UV Test

• QUV chamber test up to 3000 hours. Observation & record every 500 hours

UltraShield<sup>®</sup> 500 hrs: Delta E: 0.65 - 1.25

UltraShield<sup>®</sup> 1000 hrs: Delta E: 0.92 - 1.41

UltraShield<sup>®</sup> 1500 hrs: Delta E: 1.45 - 1.63

### UltraShield<sup>®</sup> 2000 hrs: Delta E: 2.55 – 3.54

Original Sample Tested Sample	Original Sample Tested Sample	Original Sample Tested Sample	Original Sample Tested Sample		
Model: US01. After 2500 h test, Gray Scale=3-4, △E*=2.72	Model: US02. After 2500 h test, Gray Scale=3, △ E*=3.63	Model: US02, Part showed some color change. There was no other visible surface damage. After 3000 hours test. AE*=3.75 Grav Scale 3.	Model: UH02, Part showed some color change. There was no other visible surface damage. After 3000 hours test AE*=3.56 Gray Scale 3.		
Original Sample	Original Sample Tested Sample	Original Sample Model: UH07, Part showed some color change.	Original Sample Model: US01, Part showed some color change.		
Model: UH02.   Model: UH07.     After 2500 h test, Gray Scale=3, △ E*=3.31   After 2500 h test, Gray Scale=3, △ E*=3.		There was no other visible surface damage. After 3000 hours test, $\Delta E^*=3.64$ Gray Scale 3.	There was no other visible surface damage. After 2500 hours test, $\Delta E^*=2.72$ Gray Scale 3-4.

UltraShield<sup>®</sup> 2500 hrs: Delta E: 2.72 - 3.63 UltraShield<sup>®</sup> 3000 hrs: Delta E: 2.72 - 3.75

Tested in a QUV chamber for 3000 hours, no visible colour change can be observed (Delta E <4.0)

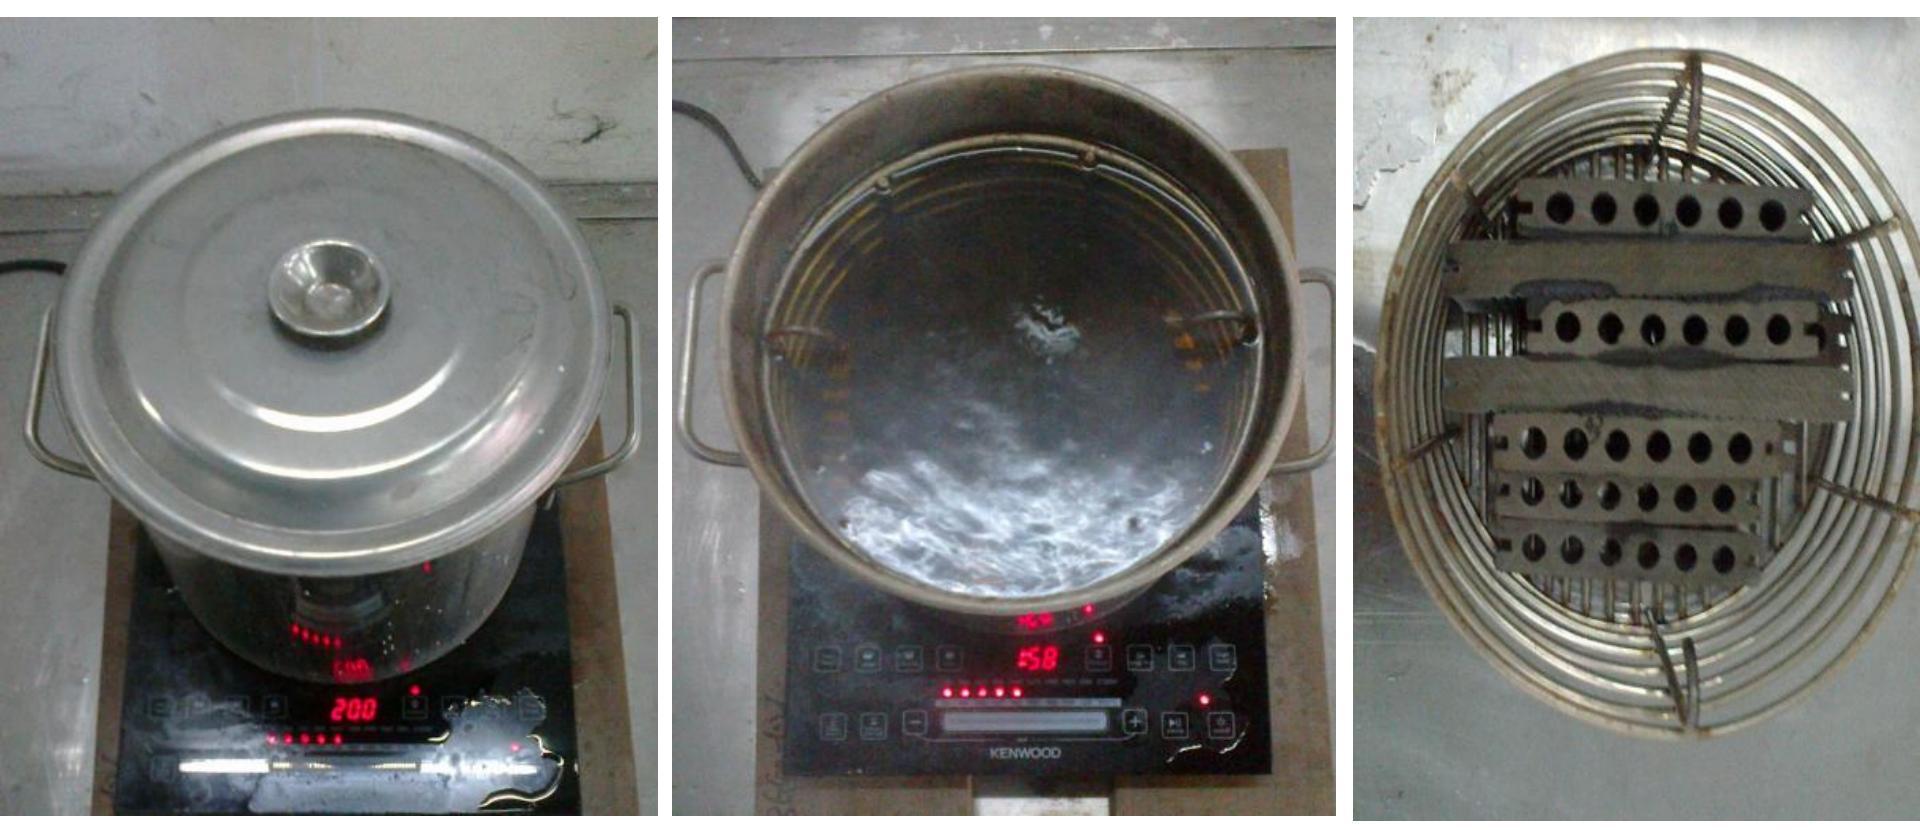
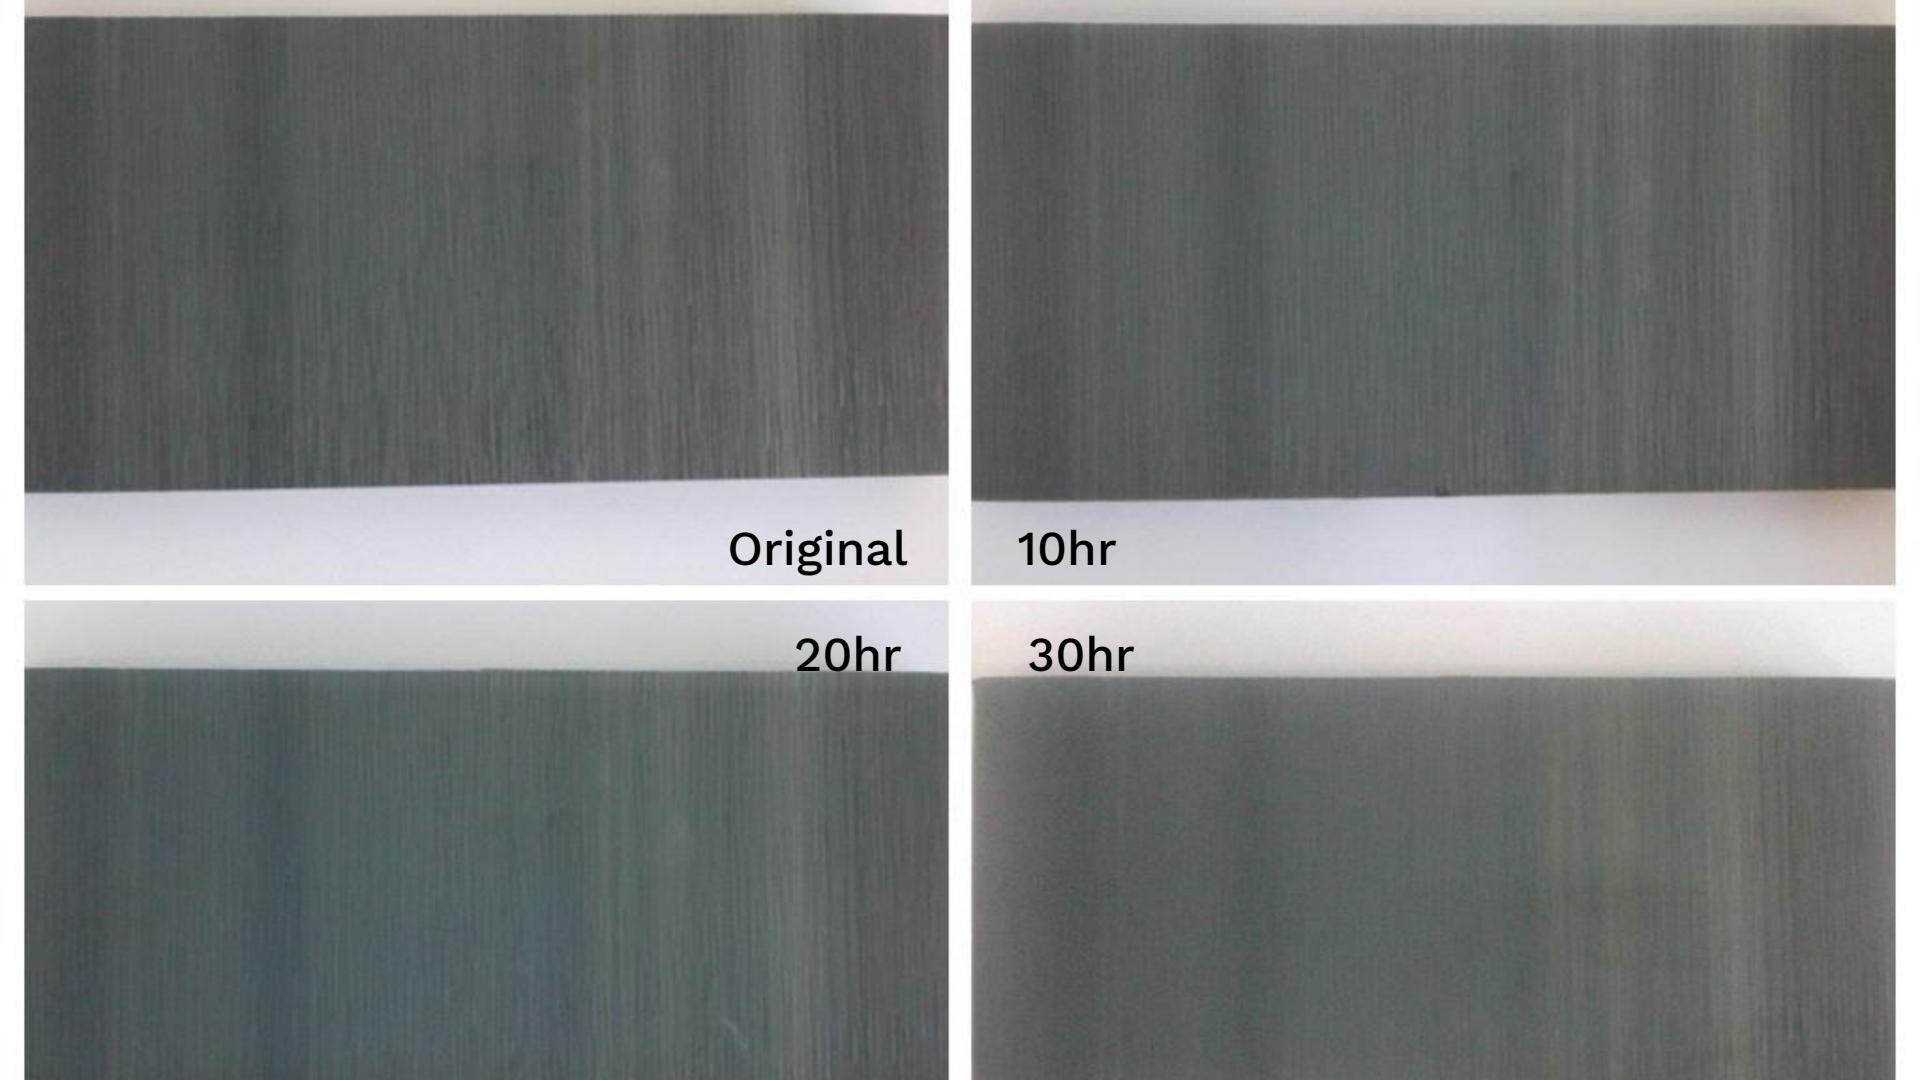
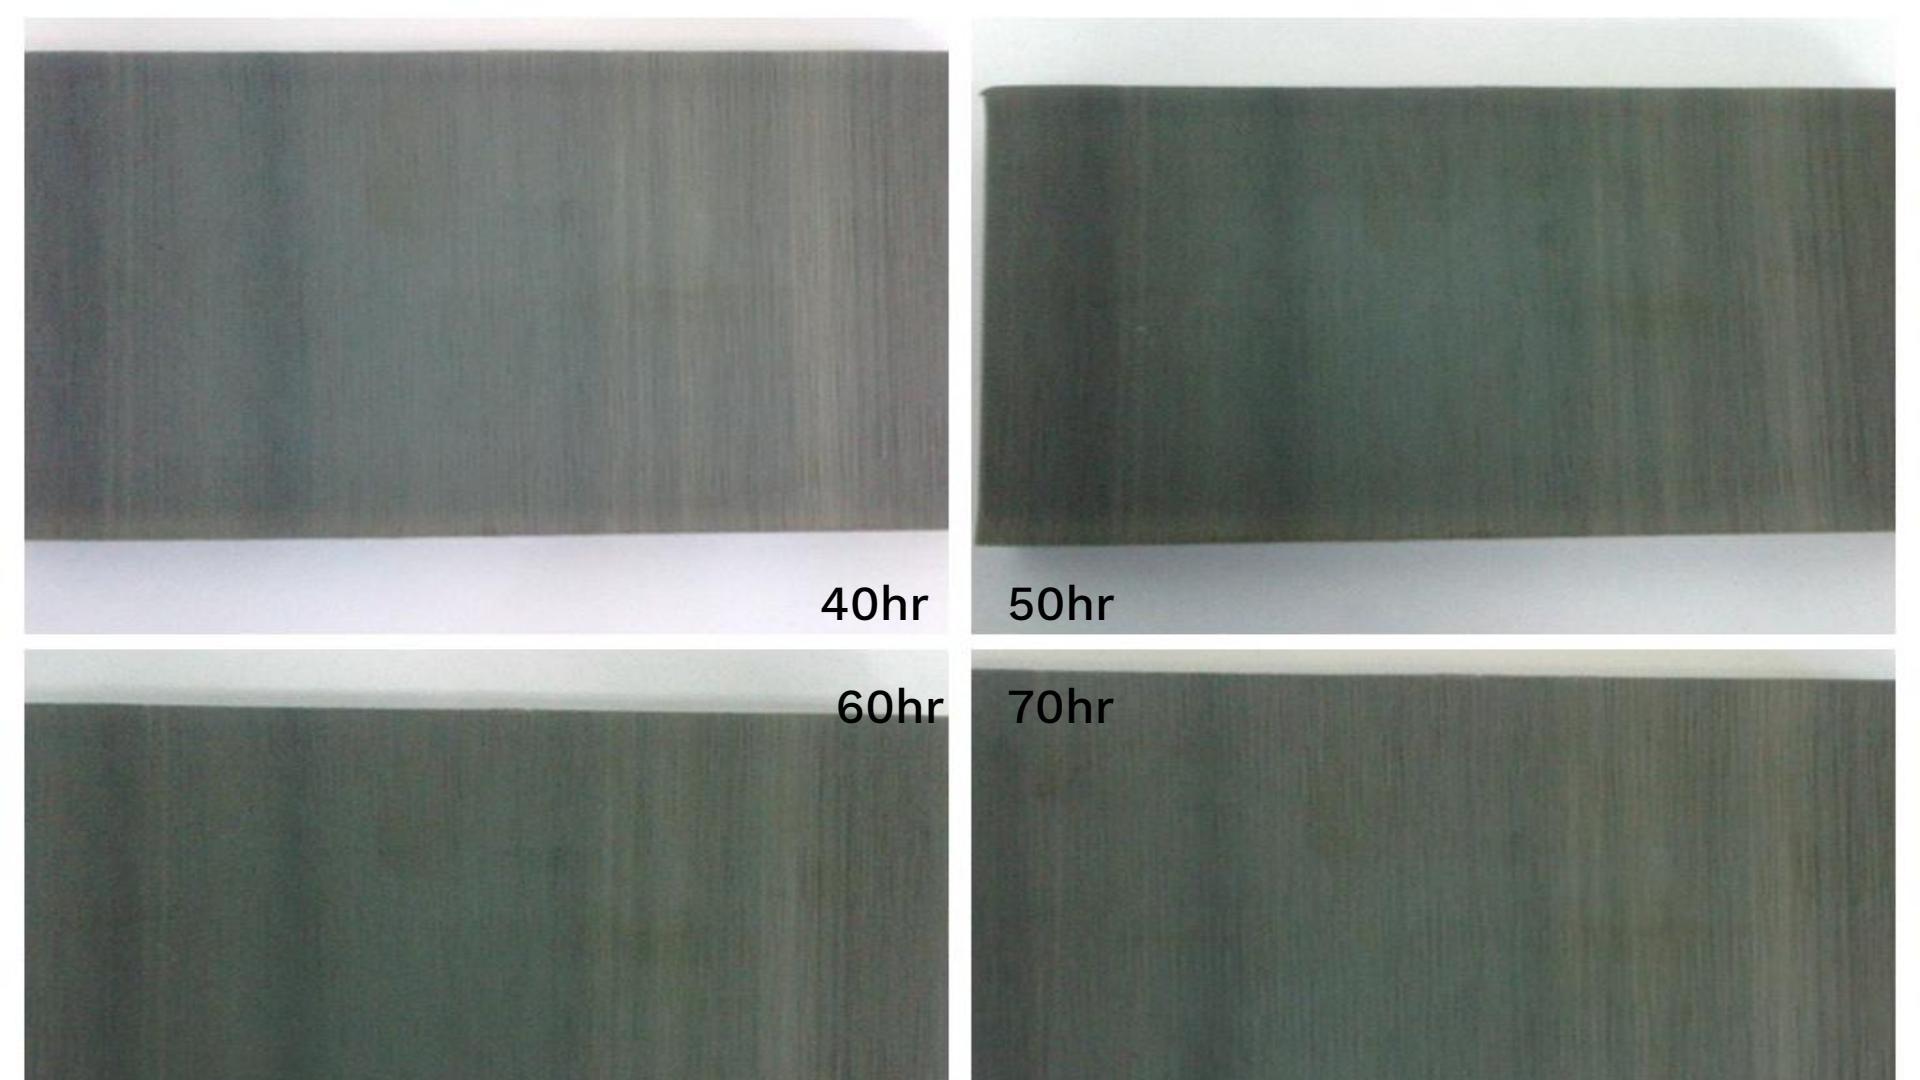
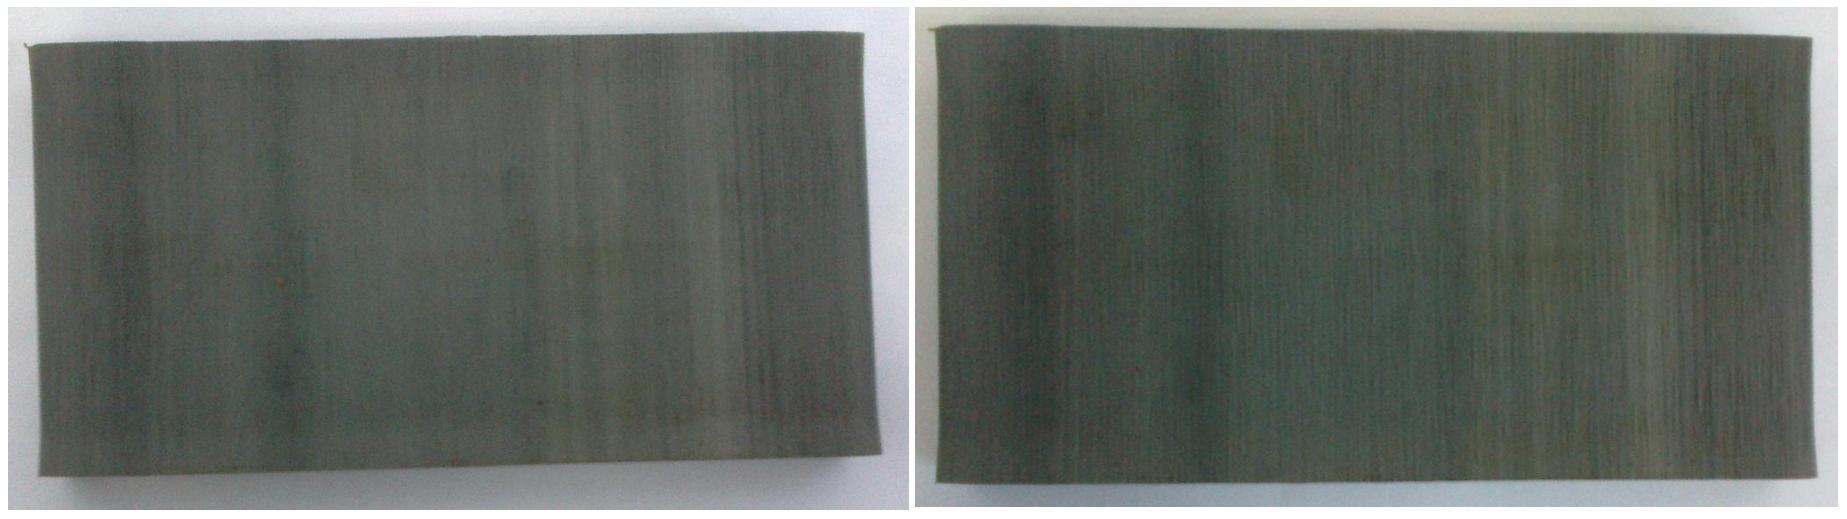
# 3.5 Boiling Test

- 1. Put the test samples in the container (the water level needs to be over the samples by at least 5mm or more
- 2. Turn on the heating plate to 100℃ and observe every 2 hours
- 3. Samples need to be taken out every day and the duration should be recorded. The duration is recorded after the temperature of the hot plate reaches 100℃
- 4. Repeat procedure 1-3 on the second day.

• Boil the board up to 80 hours or more.

80hr 90hr

Pictures above show UltraShield<sup>®</sup> after a 90 hrs boiling test. The results show no separation between the cap layer and the core, no damage and no cracking.

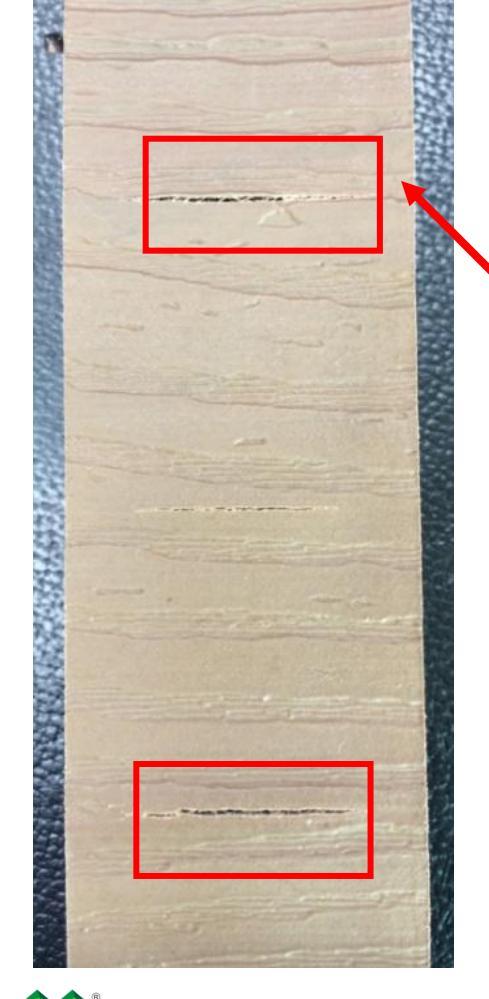
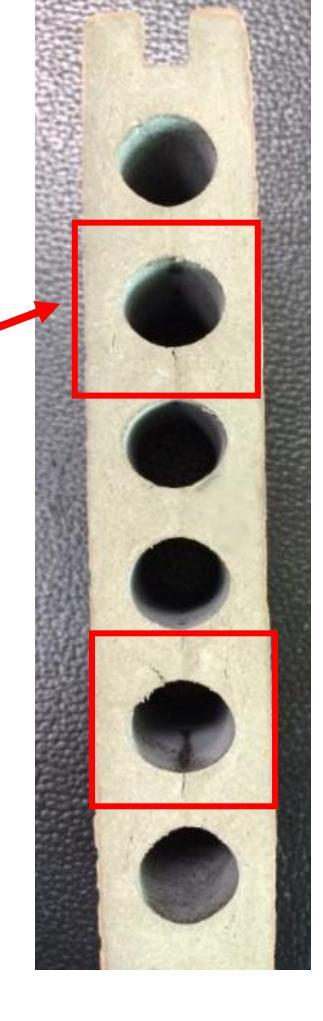
Some other Brands of fully capped composite wood shown cracking in both the capped layer and the core after 15 hrs boiling test:

The shield shown 2 cracks, 30mm The core shown 2 cracks, 3-5mm

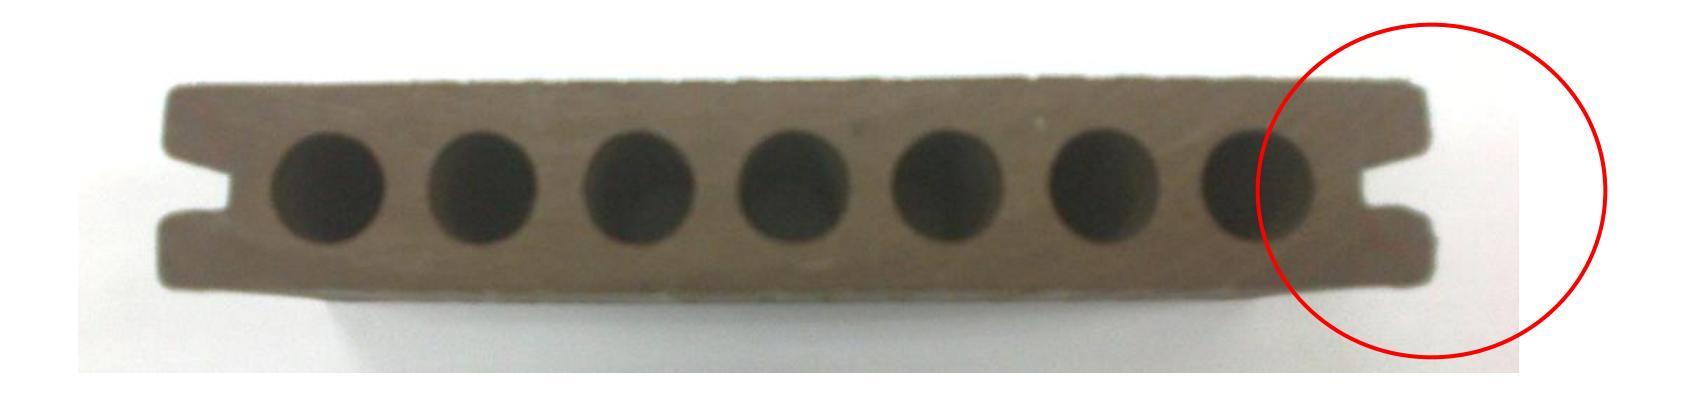
Some other Brand of fully capped composite wood shown separation after 41 hrs boiling test: Picture shown separation, 2-3mm

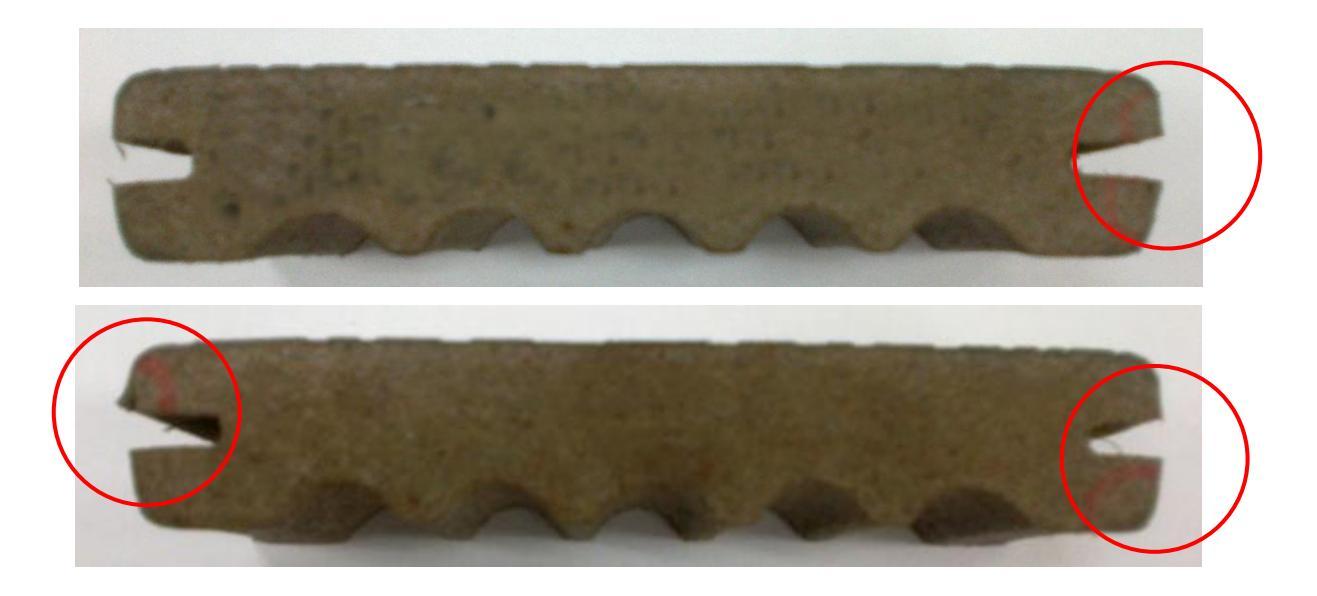
Some other Brands of groove cut capped composite wood shown separation after 18.5 hrs boiling test: Picture shown 3 spots of separation at the grooves, 2-5mm And cracking in the core 2-4mm
